New York State Department of Transportation General Bridge Inspection Report

Inspection Date: October 24, 2025

BIN: 1027670

General Type Main Span: 5 - Prestressed Concrete, 05 - Box Beam or Box Girders - Multiple

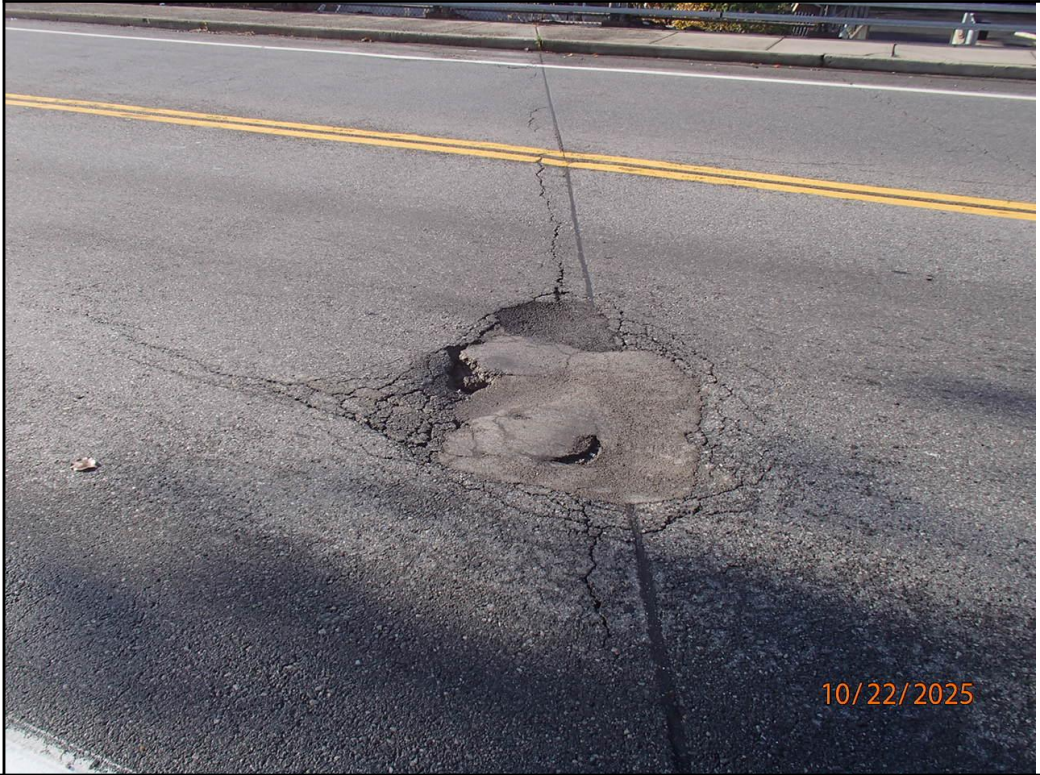
Photo Number: 3

Span 1: 12 - Reinforced Concrete Deck	TQ	CS-1	CS-2	CS-3	CS-4
	2047	612	1428	7	0
Common					
<i>Referenced Photo(s):</i> 1, 2					
<i>Referenced Sketch(es):</i> None					
--The underside of the Left fascia at the End abutment exhibits a 26" long x 5" wide x 5" high x 2.5" deep corner spall with exposed rebar containing up to 75% section loss (Photo 1).					
--The right fascia exhibits small pop-outs/delaminations over the roadway throughout the span (Photo 2). No loose concrete was noted over the roadway below. See NSCO for more information.					
Span 1: 12 - Reinforced Concrete Deck-510 - Wearing Surfaces	TQ	CS-1	CS-2	CS-3	CS-4
	1713	1641	0	72	0
Common					
<i>Referenced Photo(s):</i> 3, 4, 5					
<i>Referenced Sketch(es):</i> None					
-- At the Begin in the Left lane there is a 52" long x 55" wide depressed area with a 13" wide x 10" long x up to 4" deep pothole (Photo 3). The surrounding area is cracked up to 1/4" wide.

Attachment Description:
Wearing surface at Begin,
looking Right.

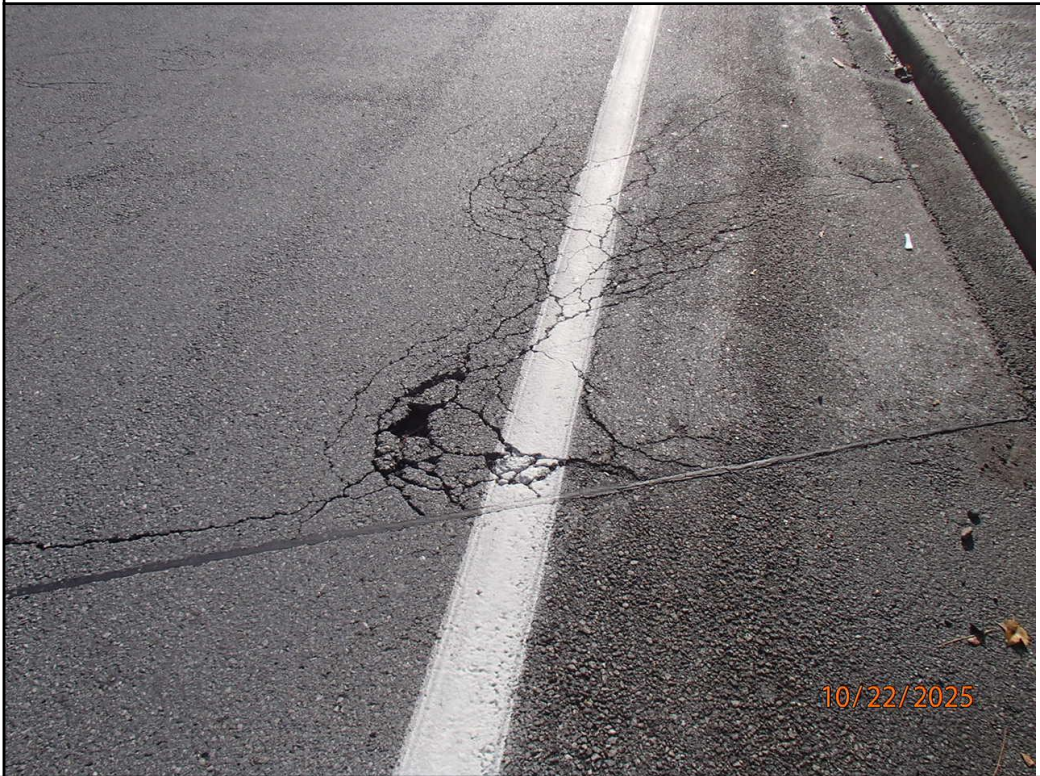
Photo Number: 4

-- At the Begin Right corner there is cracking up to 1/4" wide and the asphalt is starting to depress and break up for 20 SF with a 4"W x 6"L x 1.5"D pothole (Photo 4).					
--The End Right corner has minor cracking and there is up to 1/4"W transverse cracking for full width of roadway at End

Attachment Description:
Wearing surface at Begin
Right corner, looking End.

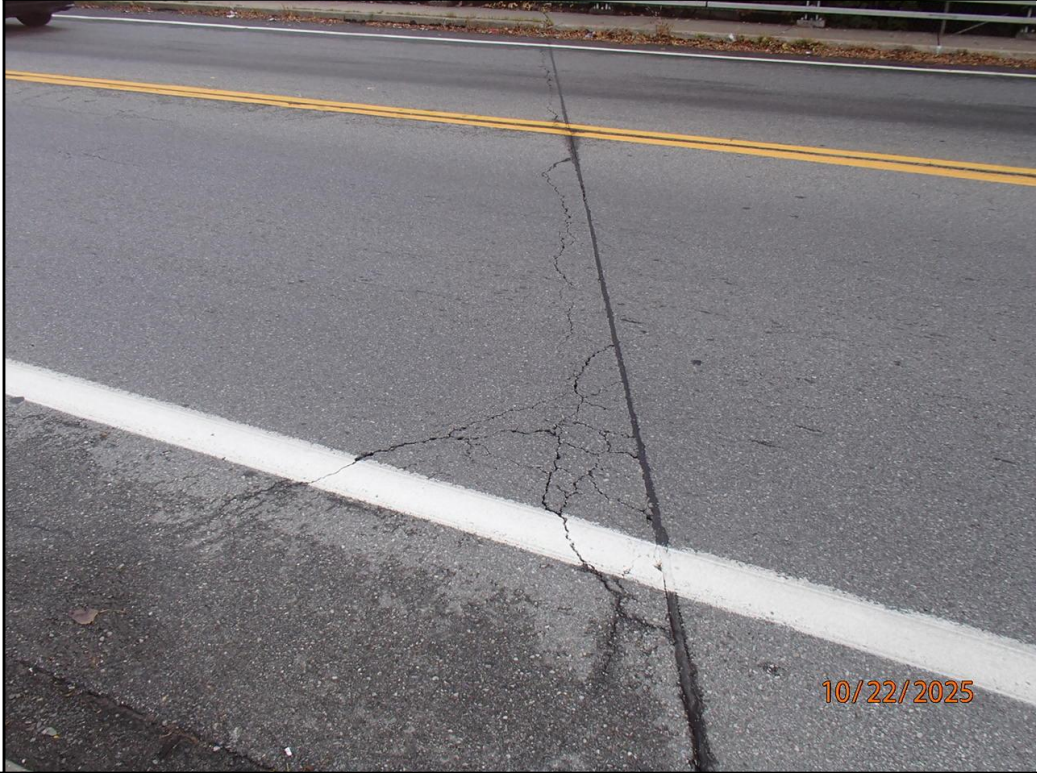
Photo Number: 5 Photo Filename: PA221050.JPG

Attachment Description:
Wearing surface at End,
looking Left.

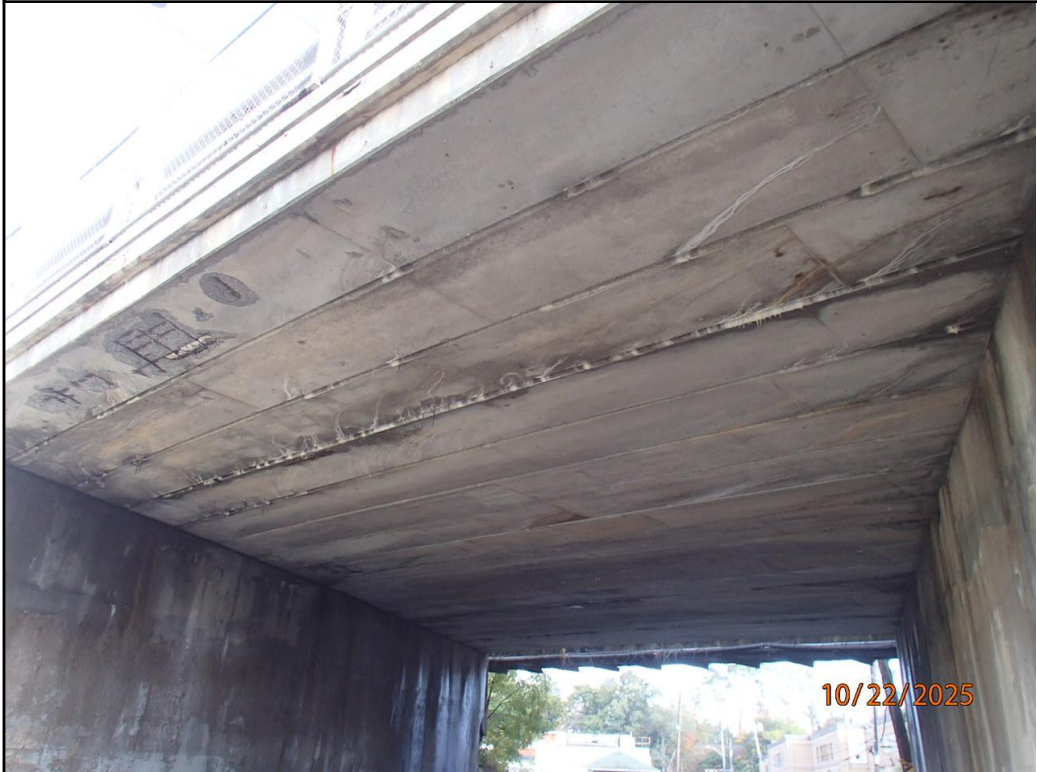
Photo Number: 6 Photo Filename: PA221064.JPG

--BIN 1027670 is prestressed concrete voided slab bridge with 17 units and a concrete deck (non-composite). The underside of the beams exhibits efflorescence and evidence of leakage at the longitudinal joints between the prestressed beams, typical throughout (Photo 6).

Attachment Description:
Underside of
superstructure, general view
from End Right, looking
Begin Left.

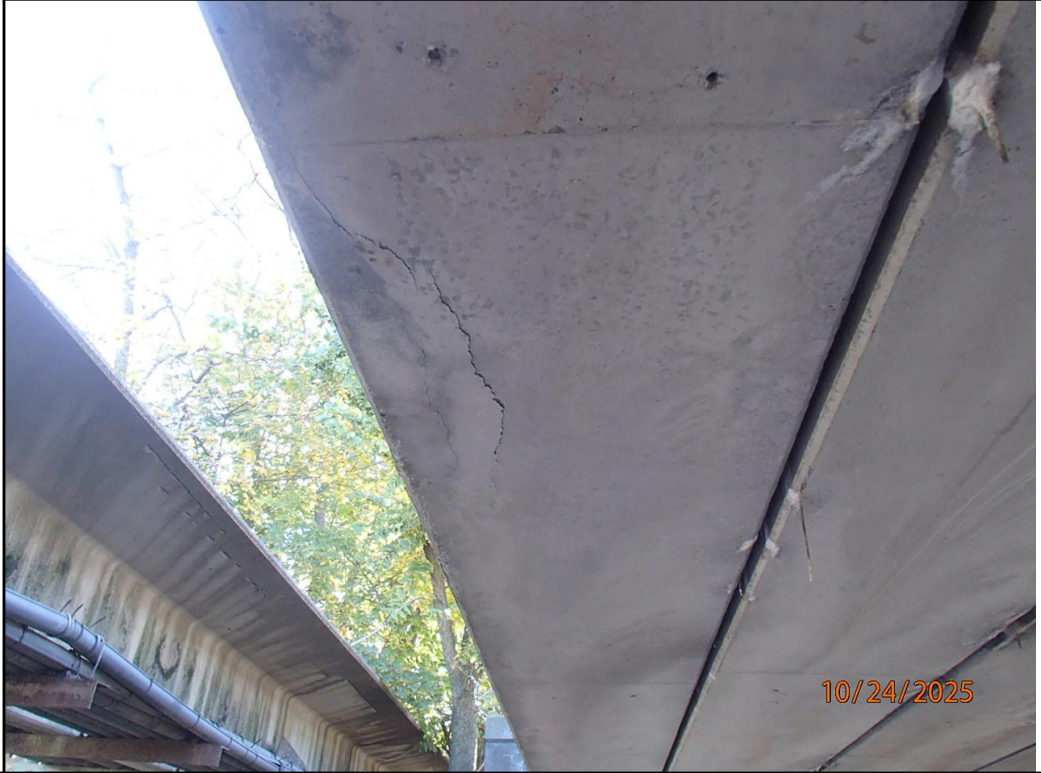
Photo Number: 7 Photo Filename: PA241173.JPG

--Beam B1: Near the Begin Abutment there is a 3 ft. long x 1/32" wide longitudinal crack with efflorescence and rust staining. 1 strand deemed ineffective. At Midspan there is a 3.5 ft. long x 12" wide edge delamination along the underside over the centerline of roadway. No loose concrete at time of inspection (Photo 7). See NSCO-1 for more details.

Attachment Description:
Underside of Beam B1 near
midspan, looking End.

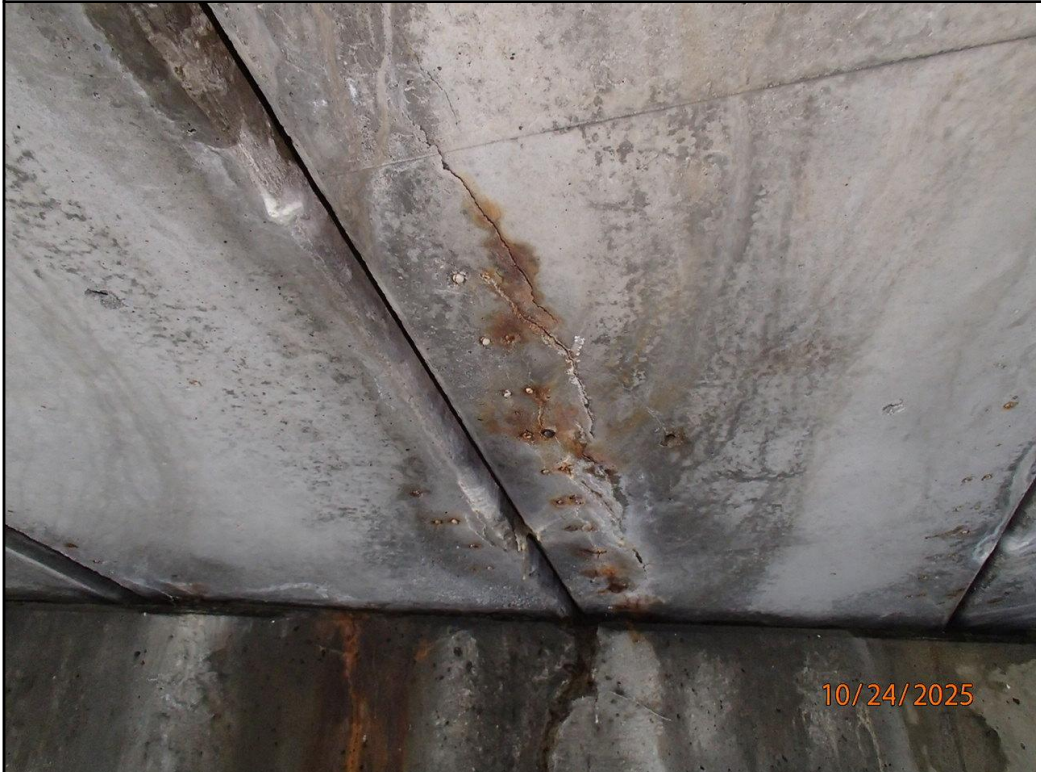
Photo Number: 8 Photo Filename: PA241177.JPG

--Beam B5: At the Begin Abutment on the Right side exhibits a 5 ft. long x up to 1/32" wide longitudinal crack with efflorescence and rust staining (Photo 8). The crack is surrounded by an 8" wide delaminated/hollow area for the full length of the crack. 1 strand is ineffective. At End Abutment at Left side there is a small corner spall 1 SF x 2" D.

Attachment Description:
Underside of Beam B5 at
Begin, looking Begin.

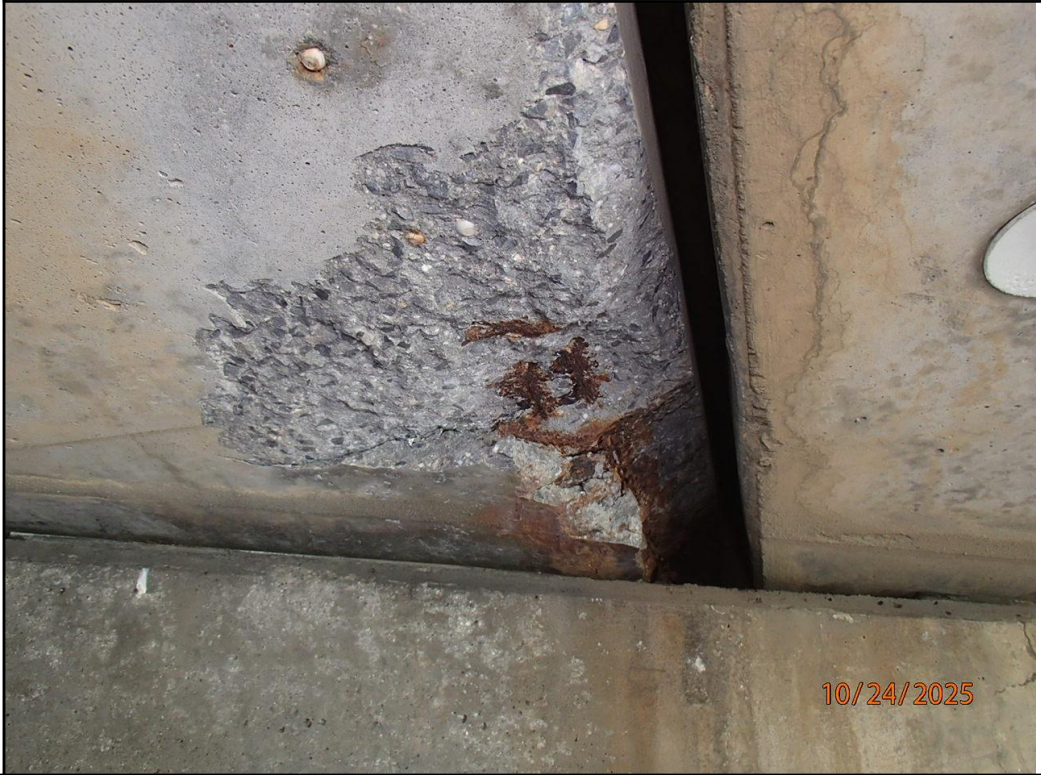
Photo Number: 9 Photo Filename: PA241168.JPG

--Beam B8: At the End Abutment, there is a 3 ft. long x 14" wide x up to 4" high x 3" deep corner spall with 2 exposed strands and one stirrup that exhibits up to 25% section loss (Photo 9).

Attachment Description:
Beam B8, bottom Right
corner at the End Abutment,
looking End.

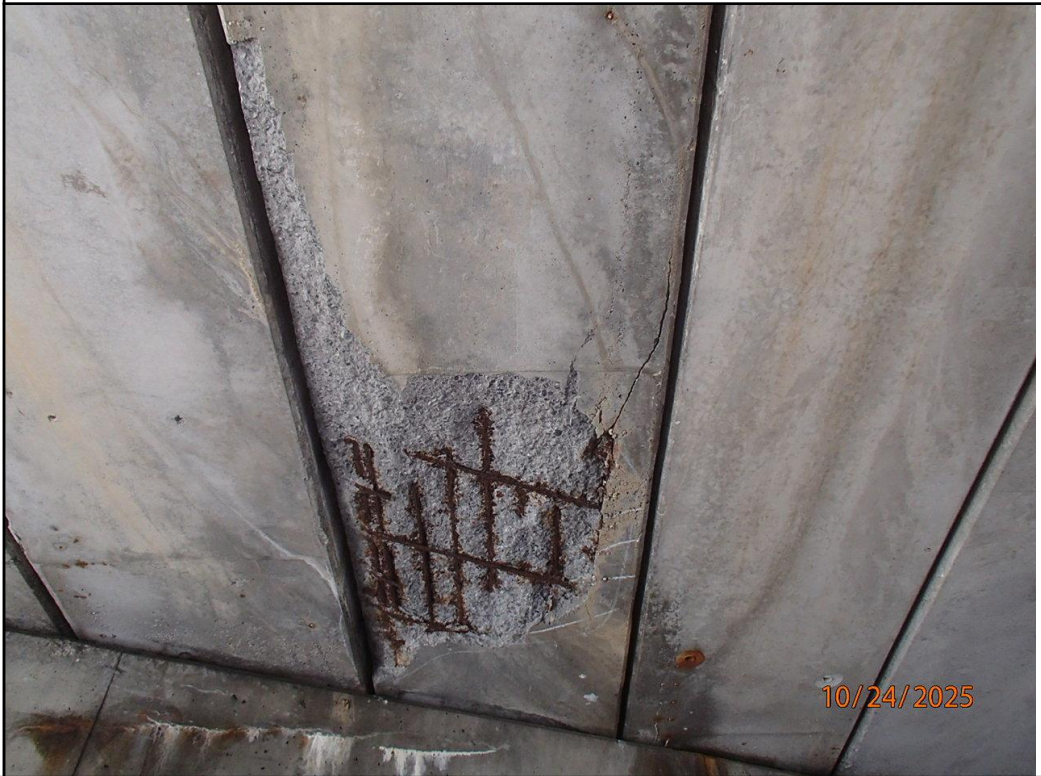
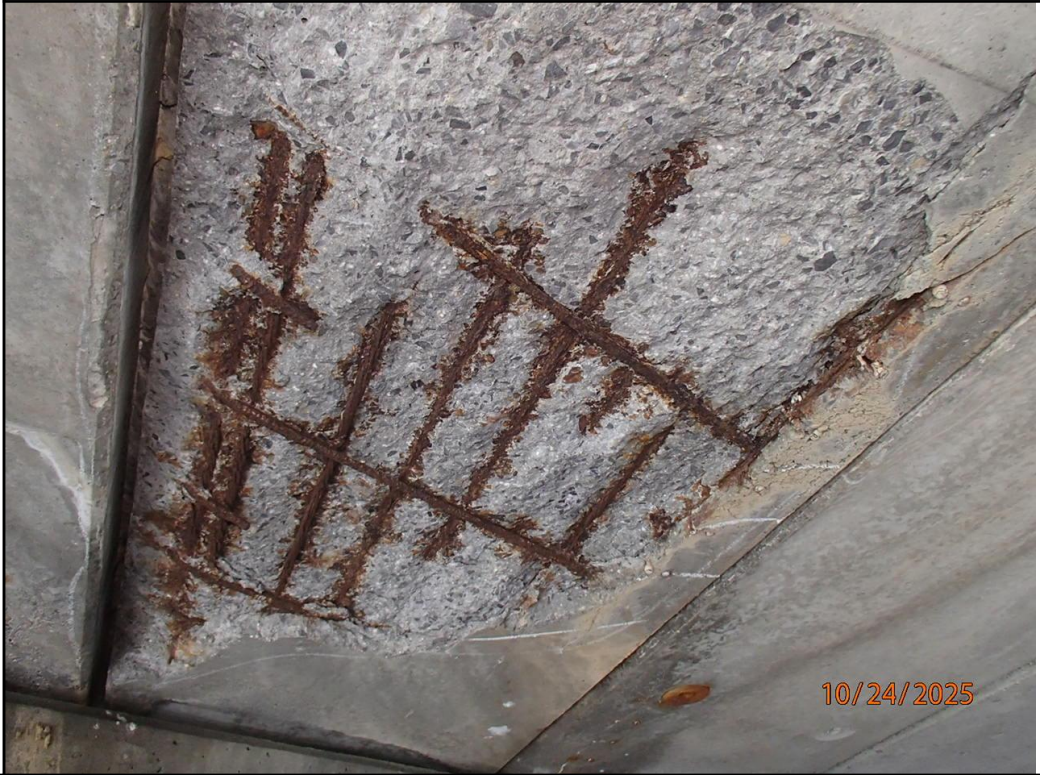
--Beam B10: At the Begin abutment there is a 7 ft. long x 2.75 ft. wide x 3" deep spall with adjacent hollow area (Photo 10). The spall exposes 3 stirrups with up to 50% section loss, 2 stirrups with 5% section loss and a total of 8 exposed prestressed strands. 4 of the 8 exposed strands are partially debonded from the concrete (Photo 11). The exposed corroded strands are assumed to be ineffective. This spall rates CS4. No evidence of distress was observed and the adjacent Beams B9 & B11 are in fair condition with no significant defects. This condition was flagged in 2020 (Yellow Flag 8B20HYW029). Current deterioration is described in the level II load rating and is considered in the current 18-ton load posting; therefore, a flag is not currently warranted. The load rating has 9 removed strands from 0'-7' to be conservative. All loose concrete was removed.

Attachment Description:
Underside of Beam B10 at
Begin, looking Up and
Begin.

Attachment Description:
Underside of Beam B10 at
Begin, looking Begin.

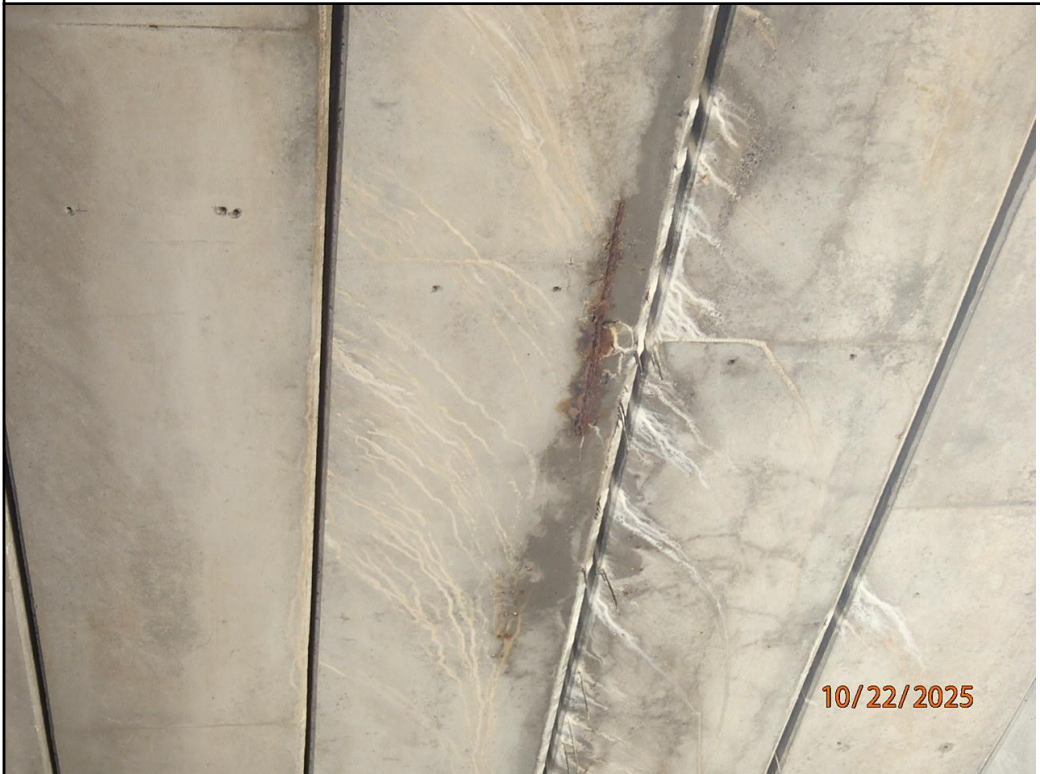
Photo Number: 12 Photo Filename: PA221077.JPG

--Beam B14: The Right side near midspan of the underside exhibits a 4 ft. long x 4" wide spall with one exposed strand due to insufficient cover (Photo 12).

Attachment Description:
Underside of Beam B14
near midspan, looking Up
and End.

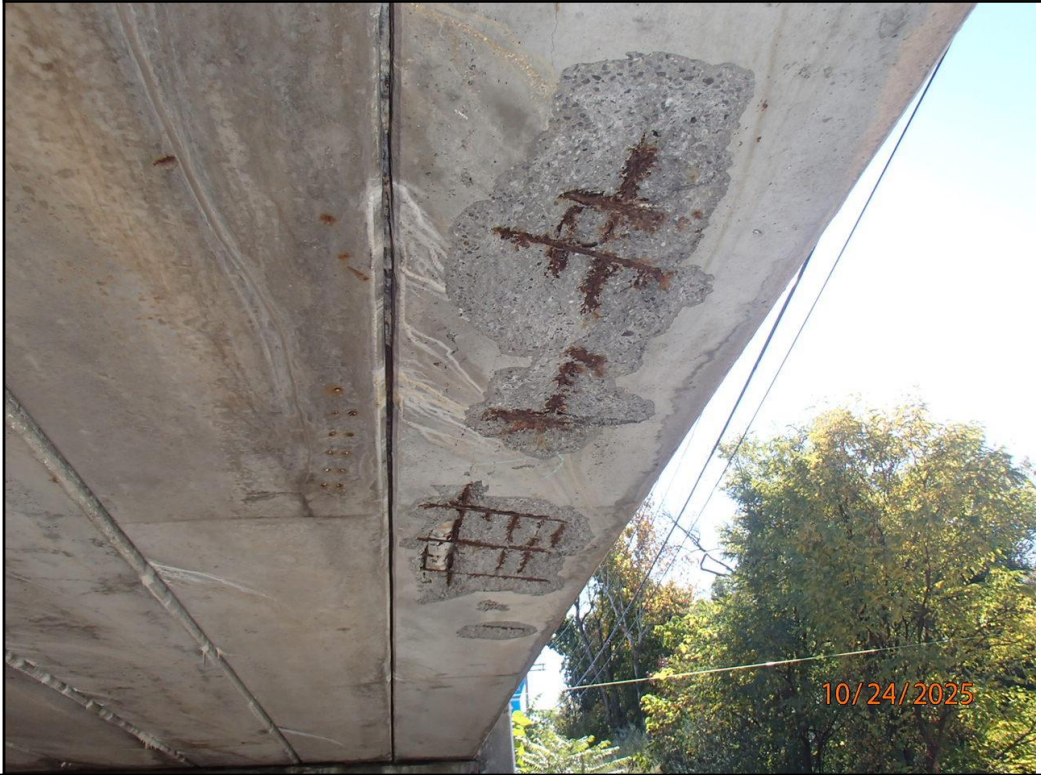
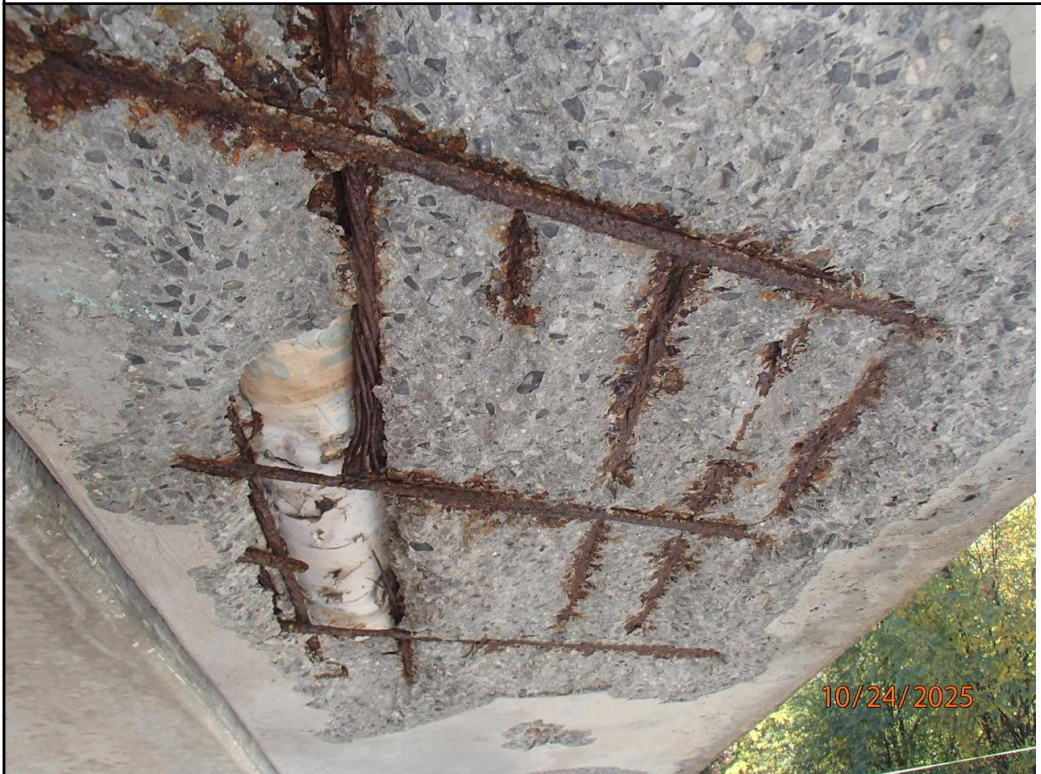
- Yellow Flag 8B25ASW018 issued (Superseding Yellow Flag 8B24CVW019) for spalling to underside of Beam B17 near mid-span.
- The structure is a single-span, prestressed concrete, voided concrete beam bridge.
- The bridge is currently posted for 18 Tons.

-- Beam B17: See Yellow Flag 8B25ASW018 for Beam B17 conditions.

Attachment Description:
Underside of Beam B17,
close-up of spall near
midspan, looking End.

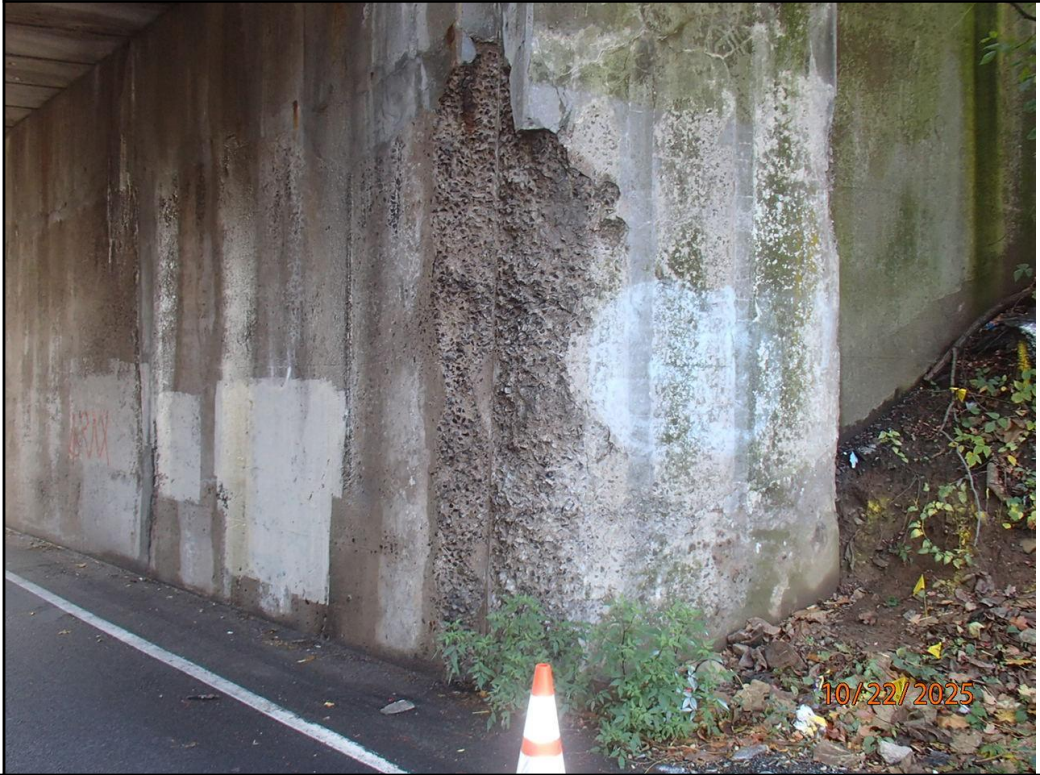
Photo Number: 15 Photo Filename: PA221075.JPG

- At the Left side at the Begin Left wingwall junction there is a 12 ft. high x 16" wide x full length x up to 6" deep corner spall with 1 exposed vertical rebar with minimal section loss (Photo 15). The spall extends into the wingwall.

-The concrete within the spalls is solid.						
Span 1: BW853 - Wingwall	TQ	CS-1	CS-2	CS-3	CS-4	CS-5
	61	0	40	21	0	0
Common						
<i>Referenced Photo(s):</i> 15, 18, 27, 28						
<i>Referenced Sketch(es):</i> None						
-- The Begin Left cheekwall exhibits scattered areas of up to 1" deep spalling for most of its area with a few locations with worse spalling noted below (Photo 27):						
-- At the junction with the Begin Abutment stem there is a 12 ft. high x up to full width on the front face and 2 ft. on the left

face x 6" deep spall (Photo 15).

Attachment Description:
Begin Abutment, general
view at Left end, looking
Begin Right.

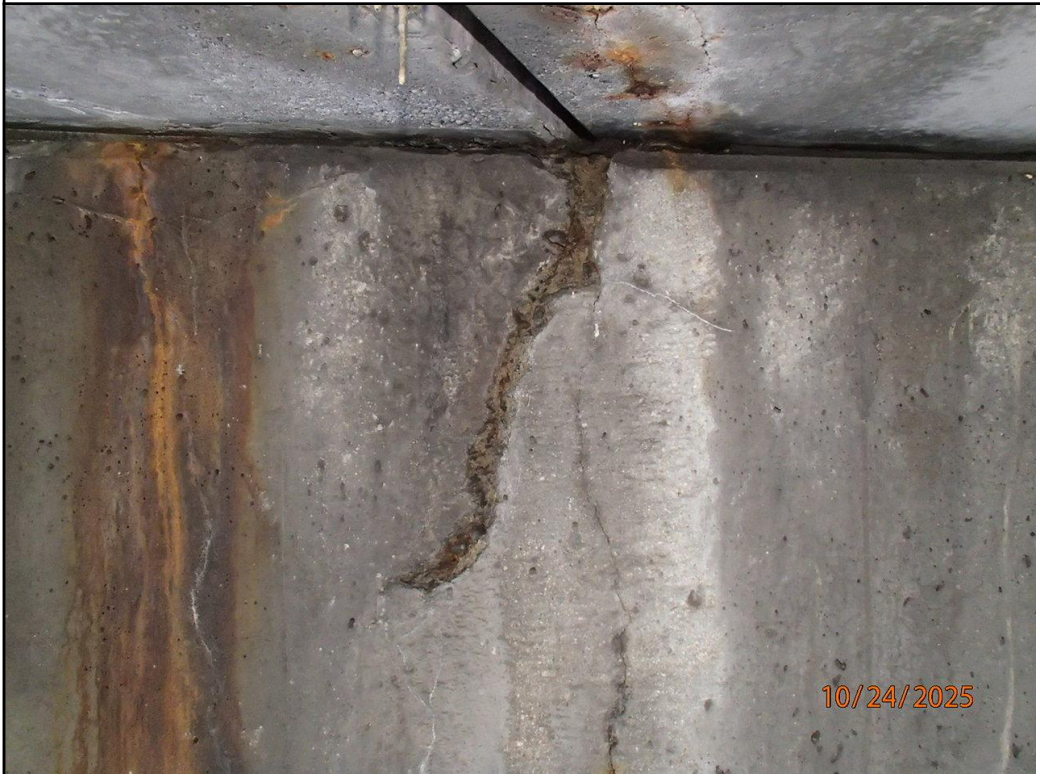
Photo Number: 16 Photo Filename: PA241176.JPG

- Below Beams B5 & B6 there is a 1/8" wide x full stem height vertical crack that has a 20" high x 10" wide x up to 2" deep spall stemming from the top of the crack (Photo 16).

Attachment Description:
Begin Abutment at top
below Beams B5 & B6,
looking Begin.

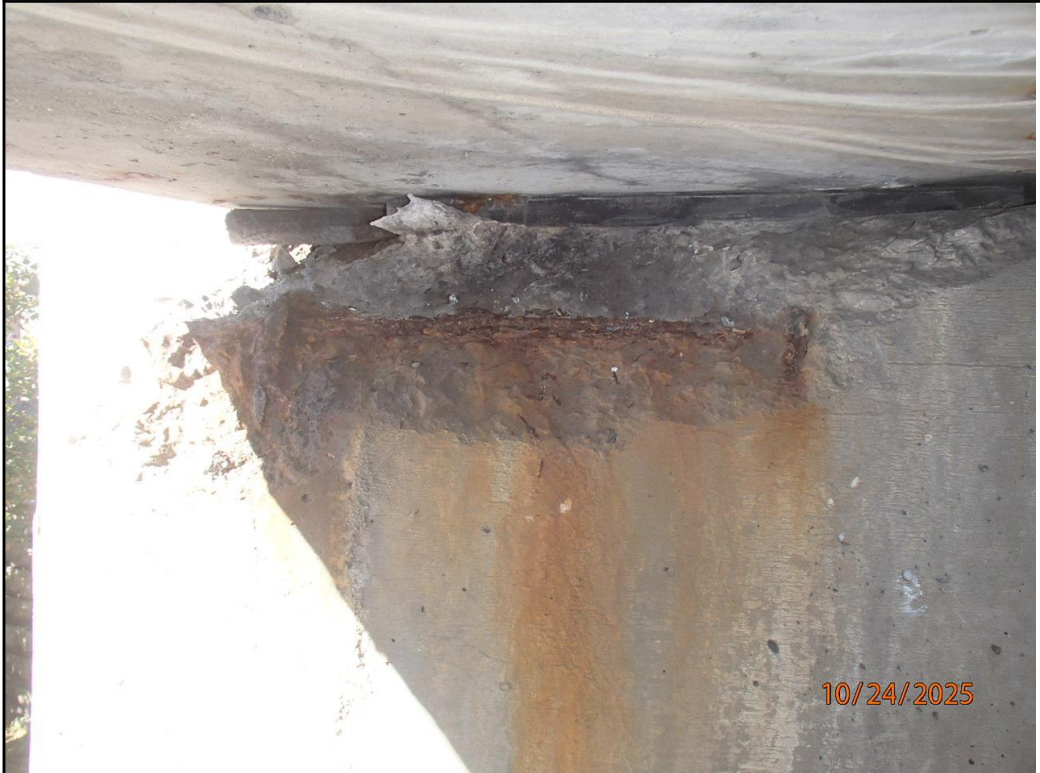
Photo Number: 17 Photo Filename: PA241185.JPG

- Below Beam B17 at the top, there is a 3 ft. wide x 12" high x up to 6" deep spall with exposed rebar containing 50% section loss (Photo 17). The bearing is undermined by less than 5%. The concrete within the spall and below the bearing is solid.

-On the Right side of Beam B17 there is a 3 ft. wide x 12" high x 6" deep spall with exposed rebar containing 50% section loss underneath (Photo 17). The bearing is undermined by <5%. Remaining concrete below the bearing is solid.						
-The concrete within the spalls is solid.						
Span 1: EA851 - Abutment Pedestal	TQ	CS-1	CS-2	CS-3	CS-4	CS-5
	17	0	13	4	0	0
Common						
<i>Referenced Photo(s):</i> 22, 23						
<i>Referenced Sketch(es):</i> None						
--The top of the End Abutment below the beams is rated as the pedestal area. Conditions are as follows:						
-Below Beams B9 and B10 there is a 16" high x 3 ft. long x 4" deep spall with no undermining of the bearing (Photo 22).						
-Below Beams B10 and B11 there is a 2 ft. long x 6" high x 6" deep delaminated and spalled area with less than 2% undermining at the Beam B10 bearing (Photo 23). Remaining concrete below the bearing is solid.						
-Below Beam B13 there is a 1 ft. long x 2" high x 5" deep spall with an adjacent 2 ft. long x 1/8" wide horizontal crack. The bearing is not undermined.

Attachment Description:
Begin Abutment at top
below Beam B17, looking
Begin.

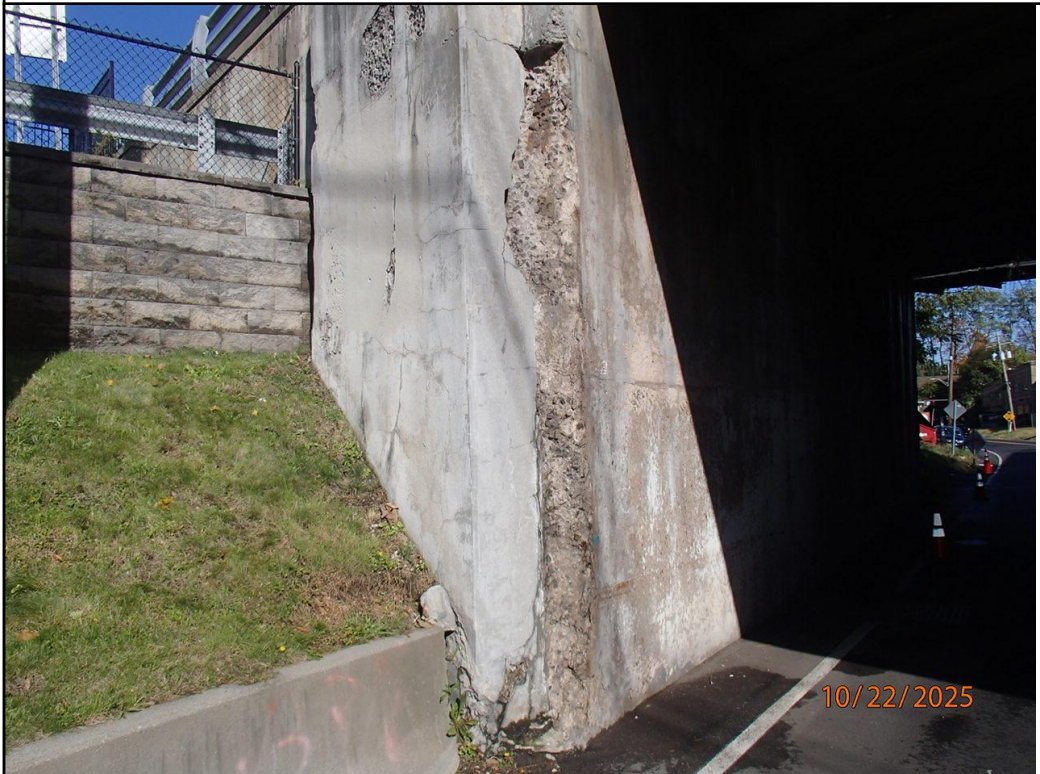
Photo Number: 18 Photo Filename: PA221083.JPG

- The Right edge of the Begin Abutment has a 13 ft. high x 12" wide x full length x up to 6" deep corner spall that extends into the Begin Right wingwall (Photo 18).

- At the top Right corner there is a 3.5 ft. high x 6" wide x 4" deep spall with some exposed fill within the top of the front face and up to 1/8" wide map cracking throughout (Photo 18).

- On the Right side of the cheekwall near the base there is a 2 ft. high x 6" wide x 1" deep spall surrounded by hollow/delaminated concrete.
 - At the top Right face of the cheekwall is a 3 ft. wide x 2 ft. high x 1" deep spall (Photo 18).

Attachment Description:
Begin Abutment, Right end
of stem and right cheekwall,
looking Begin Left.

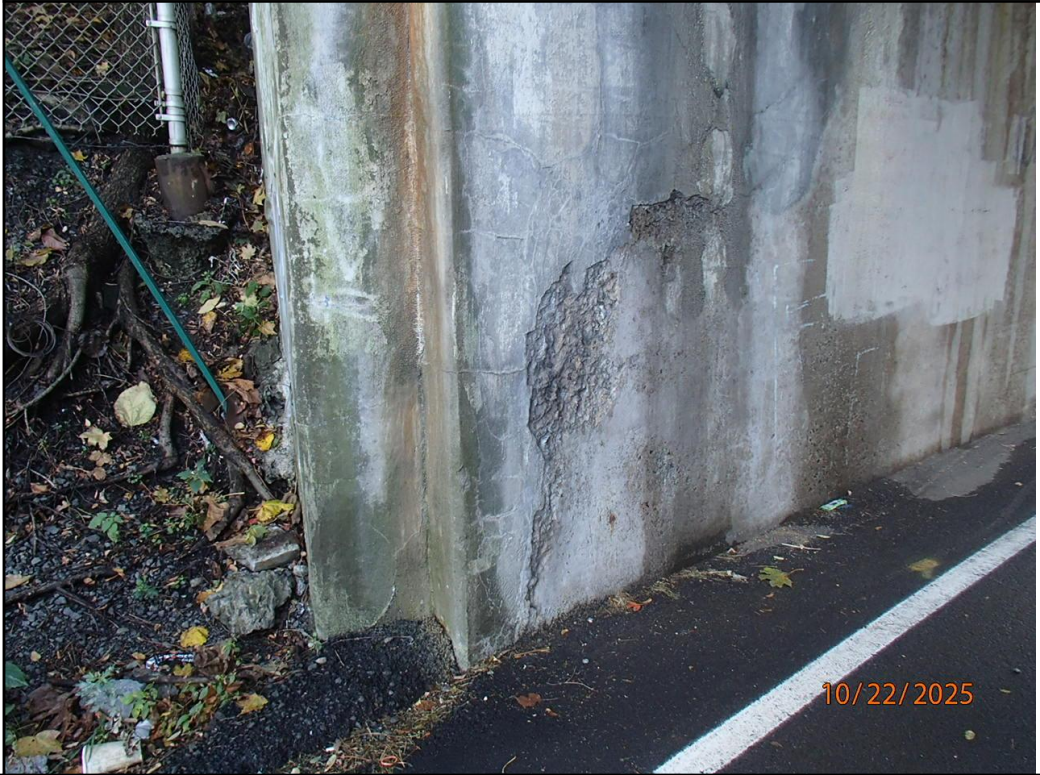
Photo Number: 19

- The Left end of stem exhibits a 4 ft. high x 2 ft. wide x 1" deep spall at the base (Photo 19).
- The top of the stem below Beams B1 through B6 has a 1/16" wide horizontal crack with rust staining (Photo 20). There is also heavy efflorescence below Beams B1 and B2.

Attachment Description:
End Abutment, bottom of stem at Left end, looking End.

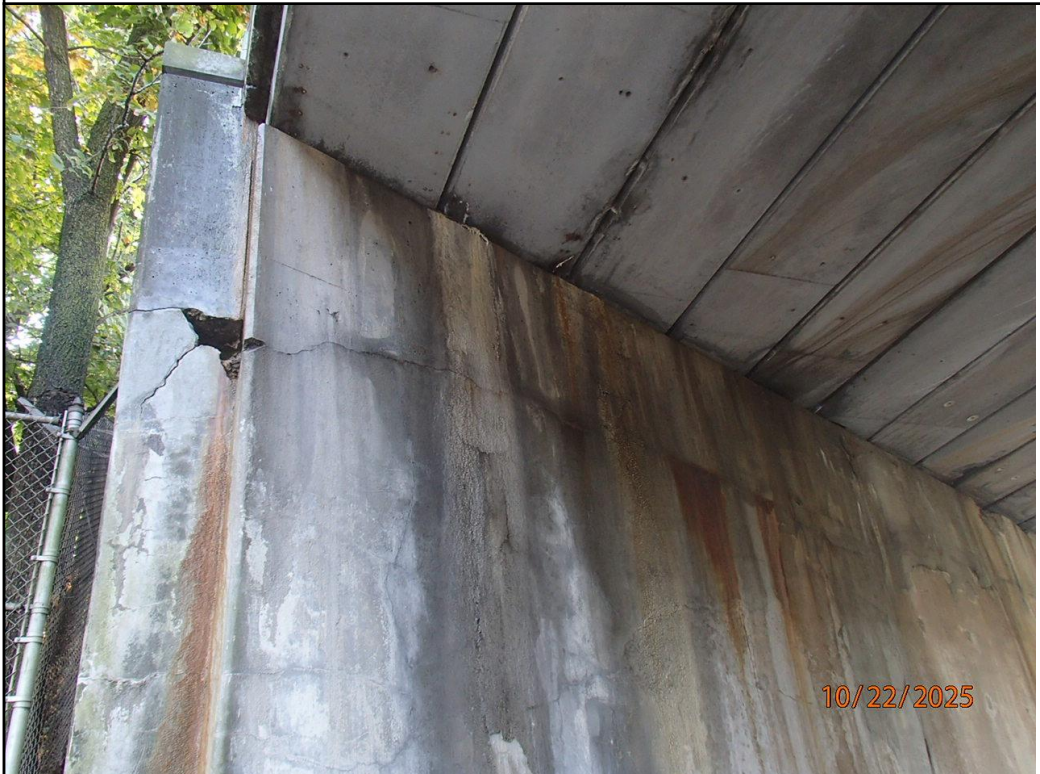
Photo Number: 20

Attachment Description:
End Abutment, top of stem at left end, looking End.

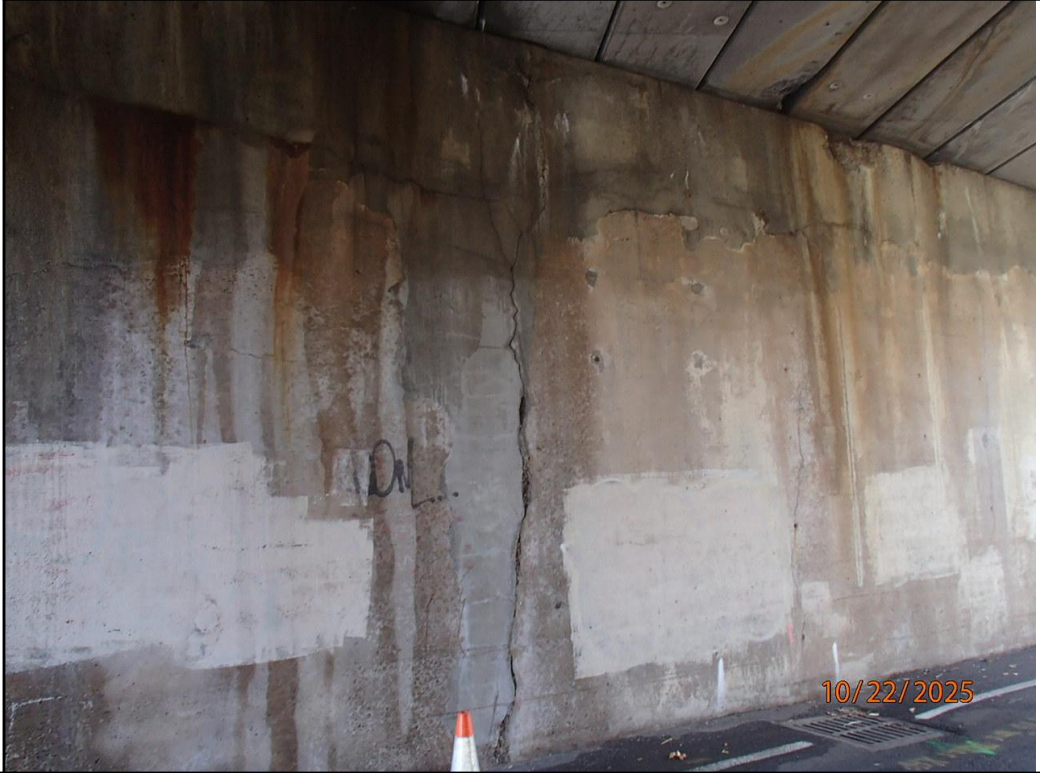
Photo Number: 21 Photo Filename: PA221058.JPG

- Below Beam B6 there is a 3/16" wide x full height vertical crack w/ efflorescence and 1.5" deep edge spalling and hollow sounding areas along the crack (Photo 21). At the top of the vertical crack, below Beams B6 and B7, there is a 8 ft. long x 1/16" wide horizontal crack with an adjacent 6 ft. wide x 3 ft. high hollow area.

Attachment Description:
End Abutment below
Beams B6 & B7, looking
End.

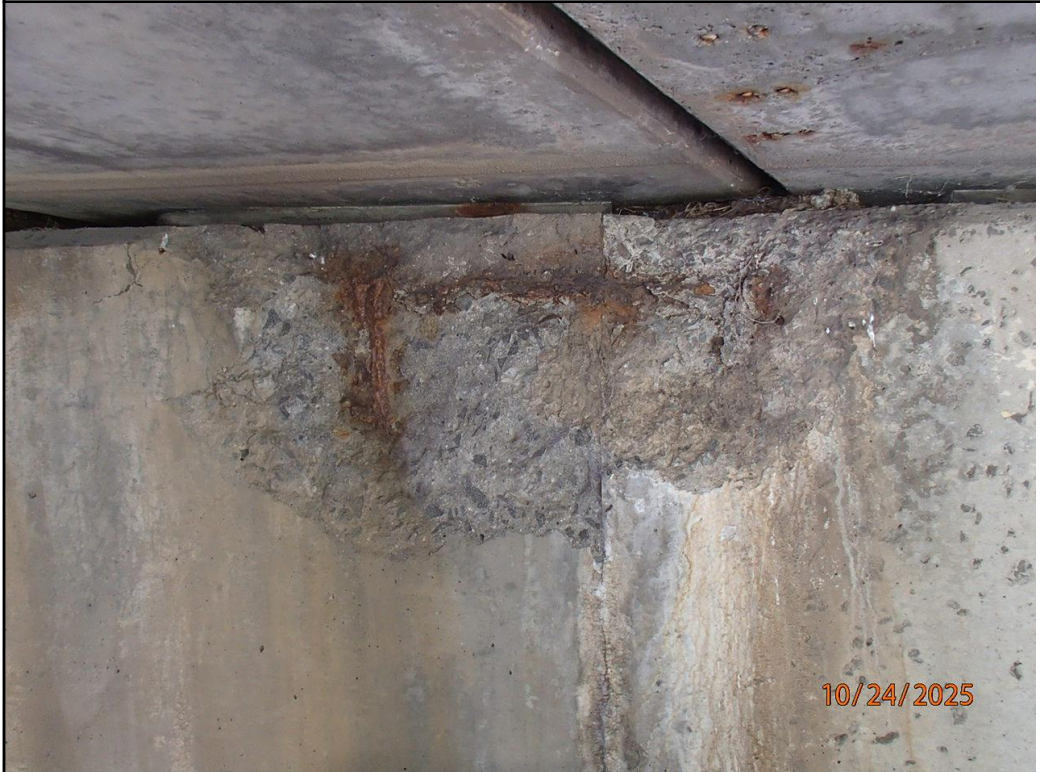
Photo Number: 22 Photo Filename: PA241167.JPG

- The top of the stem below Beams B9 and B10 exhibits a 16" high x 3 ft. wide x 4" deep spall (Photo 22). The concrete within the spall is solid.
- Below Beams B10 and B11 there is 2 ft. long x 6" high x 6" deep spall with 2 SF hollow area (Photo 23). The concrete within the spall is solid.

Attachment Description:
End Abutment at top below
Beams B9 & B10, looking
End

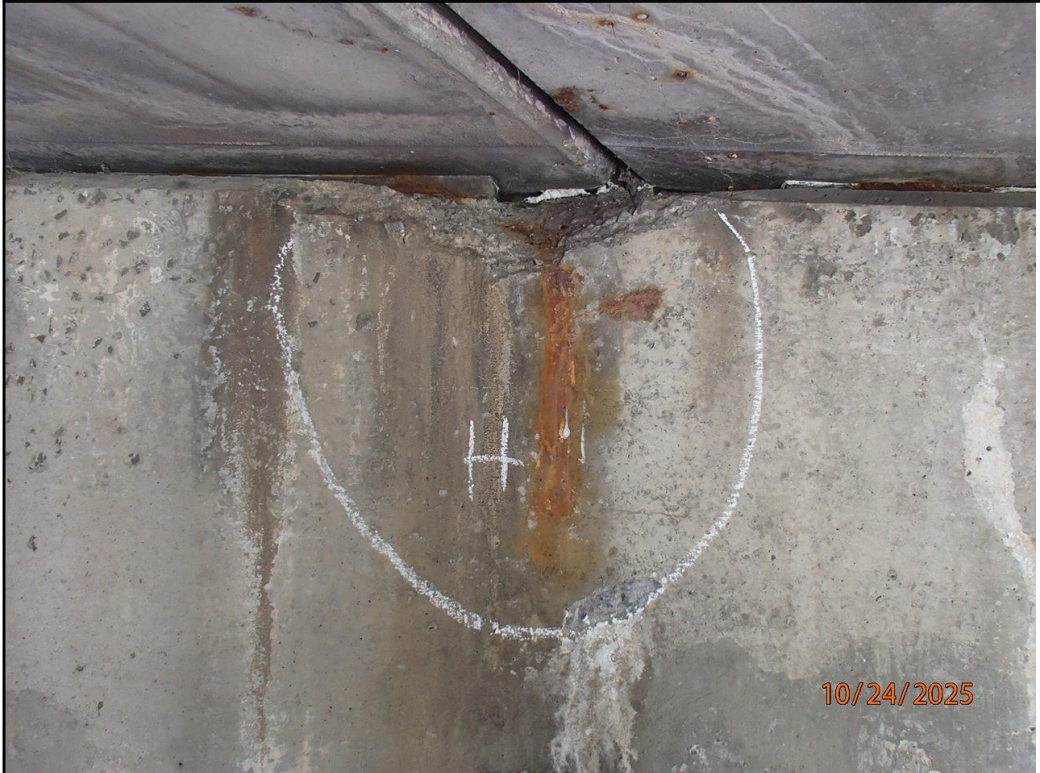
Photo Number: 23 Photo Filename: PA241165.JPG

Attachment Description:
End Abutment at top below
Beams B10 & B11, looking
End.

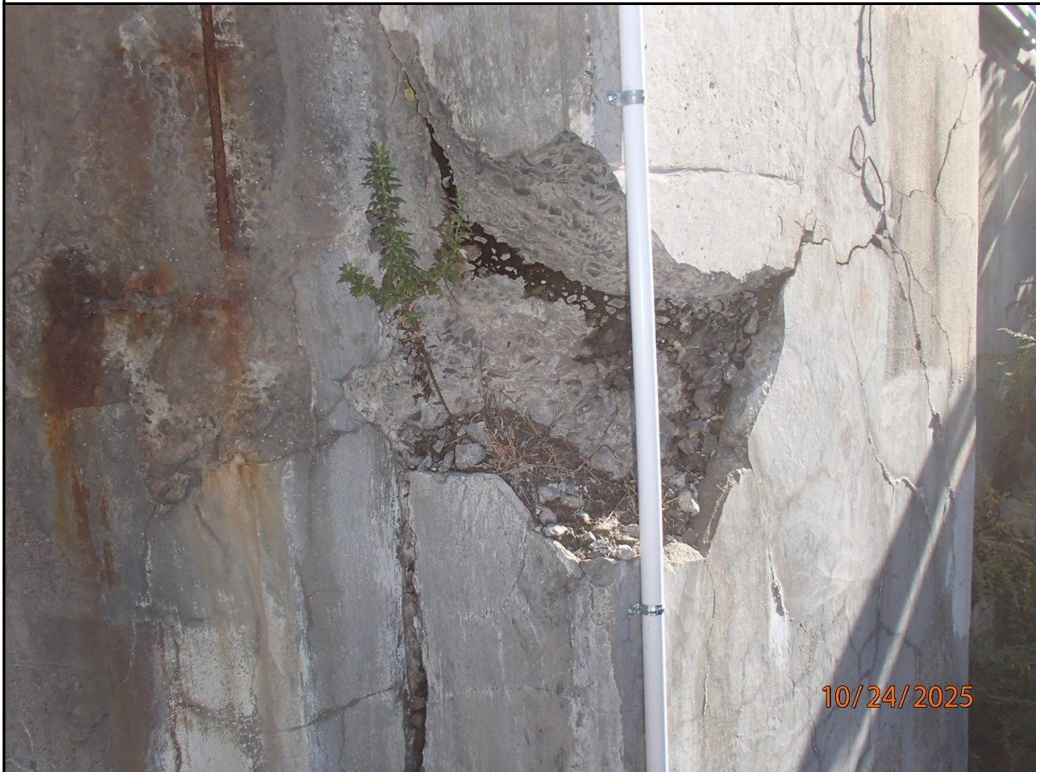
Photo Number: 24 Photo Filename: PA241160.JPG

- Below Beam B13 there is a full height 1/16" W vertical crack.
- The top Right corner of the stem exhibits a 1.5 ft. wide x 3.5 ft. high x 3" deep spall with exposed rebar containing 40% SL (Photo 24). On the bottom Right side behind the guiderail there is a 28" high x 8" wide x 1" deep spall.

- On the top Right face, there is an up to 3 ft. high x 2ft. long x 1 ft. deep x 1 ft. wide (FW) spall (Photo 24 and 32).
- On the front face of the cheek wall there is a 10" wide x 6 ft. high x 3" deep spall.
- On the Right side towards the Begin there is a 43" high x 27" long x 2.5" deep spall near the base.
- On the End Right back corner of the Right cheekwall there is a spall measuring 20" high x 6" long x 2" deep. The remainder of the cheek wall exhibits scatted patches with up to 1/4"W map cracking.
- The End Right wingwall at the cheekwall junction exhibits a full height x 2 ft. wide x 3" deep spalled/delaminated and crack area (Photo 33).

Attachment Description:
End Abutment, Right end of
stem/right cheekwall near
top, looking End Left.

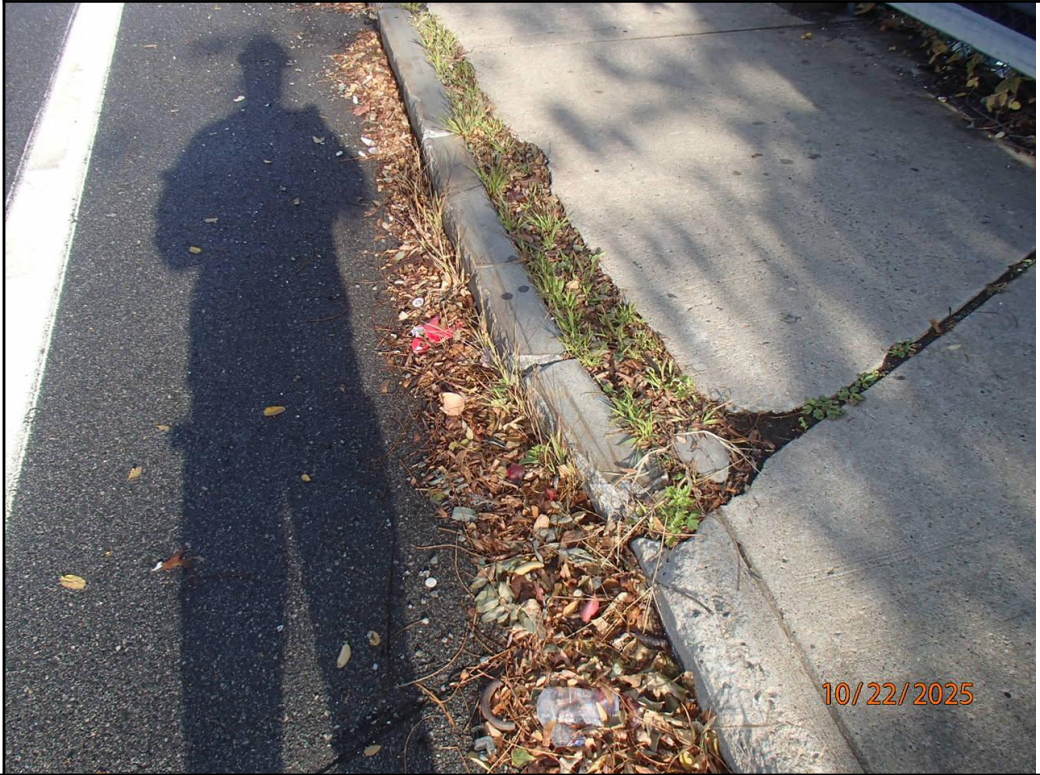
Photo Number: 25 Photo Filename: PA221041.JPG

The Left sidewalk exhibits edge spalling along the curb up to 8"W for the full length with vegetation growth along the spalls (Photo 25).

Span 1: 811 - Curb	TQ	CS-1	CS-2	CS-3	CS-4	CS-5
	79	39	30	9	1	0
Common						
<i>Referenced Photo(s):</i> 25						
<i>Referenced Sketch(es):</i> None						
At the End left the curb is pushed out towards the roadway by up to 3" due to vegetation growth. There is also a full height x full width x 8" long spall at the End.						
Span 1: BA850 - Backwall	TQ	CS-1	CS-2	CS-3	CS-4	CS-5
	52	52	0	0	0	0
Span 1: EA850 - Backwall	52	52	0	0	0	0
Common						
<i>Referenced Photo(s):</i> None						
<i>Referenced Sketch(es):</i> None						
The backwall is not visible for inspection and is therefore rated CS-1.						
Span 1: BA851 - Abutment Pedestal	TQ	CS-1	CS-2	CS-3	CS-4	CS-5
	17	0	14	3	0	0
Common						
<i>Referenced Photo(s):</i> 16, 17						
<i>Referenced Sketch(es):</i> None						
--The top of Begin Abutment below the beams is rated as the pedestal area. Conditions are as follows:						
-Below Beams B5 & B6 there is a 20" high x 10" wide x up to 2" deep spall stemming from the crack below (Photo 16).

Attachment Description:
Left bridge sidewalk and curb at End, looking Begin.

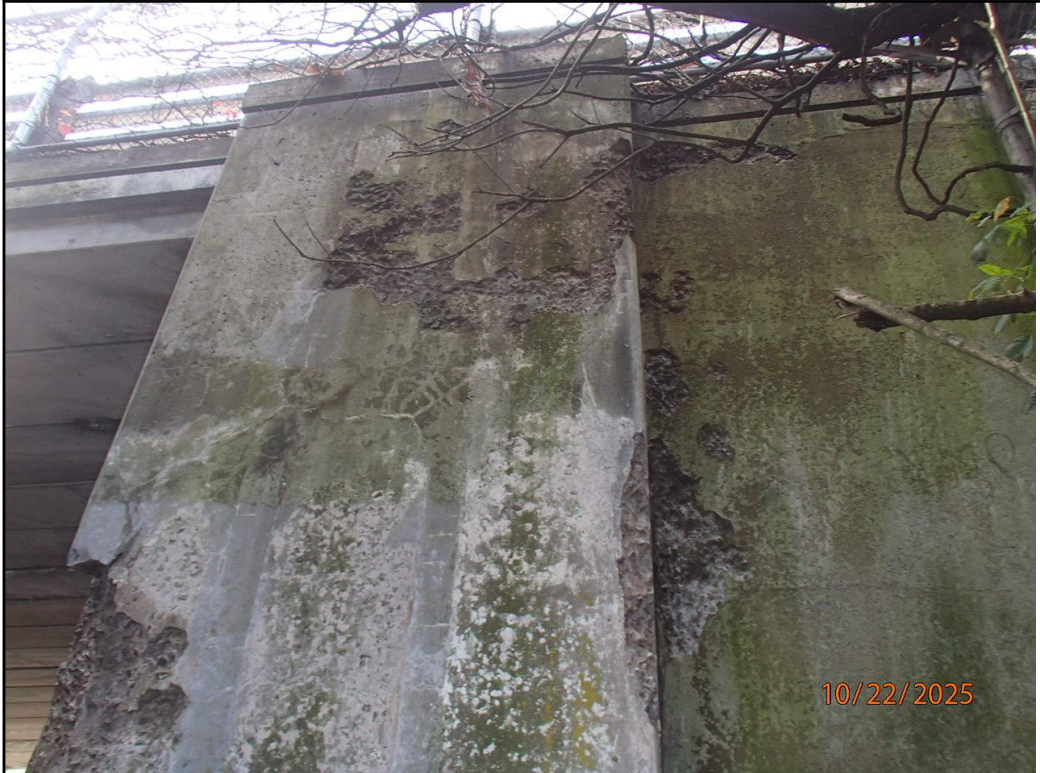
Photo Number: 27 Photo Filename: PA221071.JPG

- The corner separating the Begin Left cheekwall with the wingwall also exhibits a 3.5 ft. high x 6" long x 2.5" deep edge spall (Photo 27).
- The Left cheekwall has an edge spall on top at Begin measuring 2' H x 1' W x 2" D.

Attachment Description:
Begin left cheekwall and
wingwall, looking Right.
