New York State Department of Transportation General Bridge Inspection Report

Inspection Date: October 24, 2025

BIN: 1027670

General Type Main Span: 5 - Prestressed Concrete, 05 - Box Beam or Box Girders - Multiple

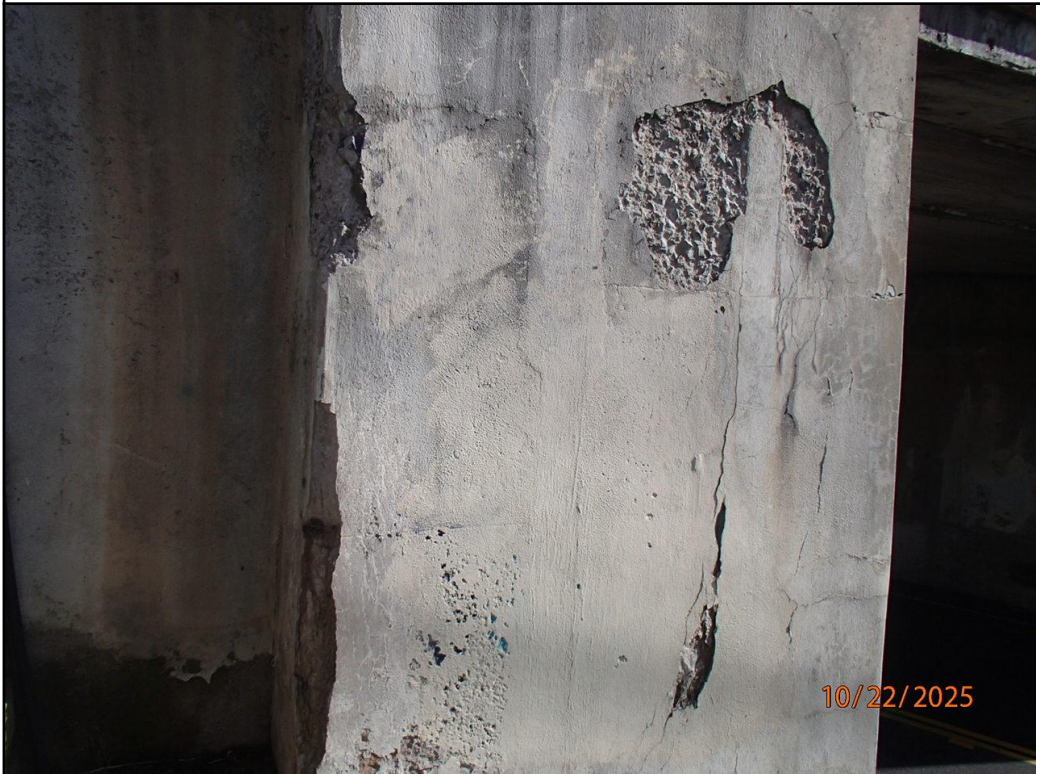
Photo Number: 28 Photo Filename: PA221082.JPG

- On the Begin face of the Right cheekwall towards the top there are 2 edge spalls measuring up to 3.5 ft. high x 18" wide x 2" deep (Photo 28).

Attachment Description:
Begin right cheekwall,
looking Left.

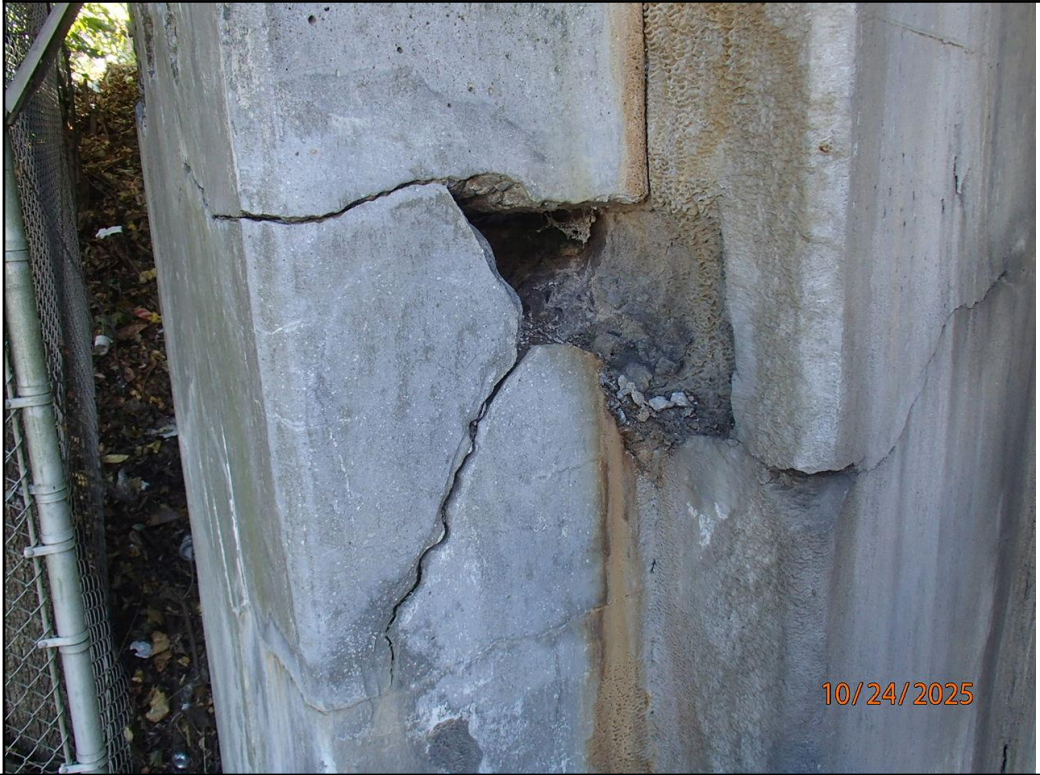
Photo Number: 29 Photo Filename: PA241171.JPG

- The front face near midheight exhibits a 12" high x 11" wide x 11" deep spall with adjacent 3/8"W cracking and adjacent delaminated area (Photo 29).
- The End face of the cheekwall has a spall measuring 3.5" H x 16" W x 3" D.
- The top of the Left face exhibits a full length x 2 ft. high x up to 3" deep spalling with 1/8" wide map cracking efflorescence and scatted hollow sounding patches (Photo 30).
- The End Left wingwall at the top exhibits scattered spalling for up to 9 ft. long x 4 ft. high x up to 3.5" deep (Photo 31).

Attachment Description:
Front face of End Left
cheekwall near mid-height,
looking End.

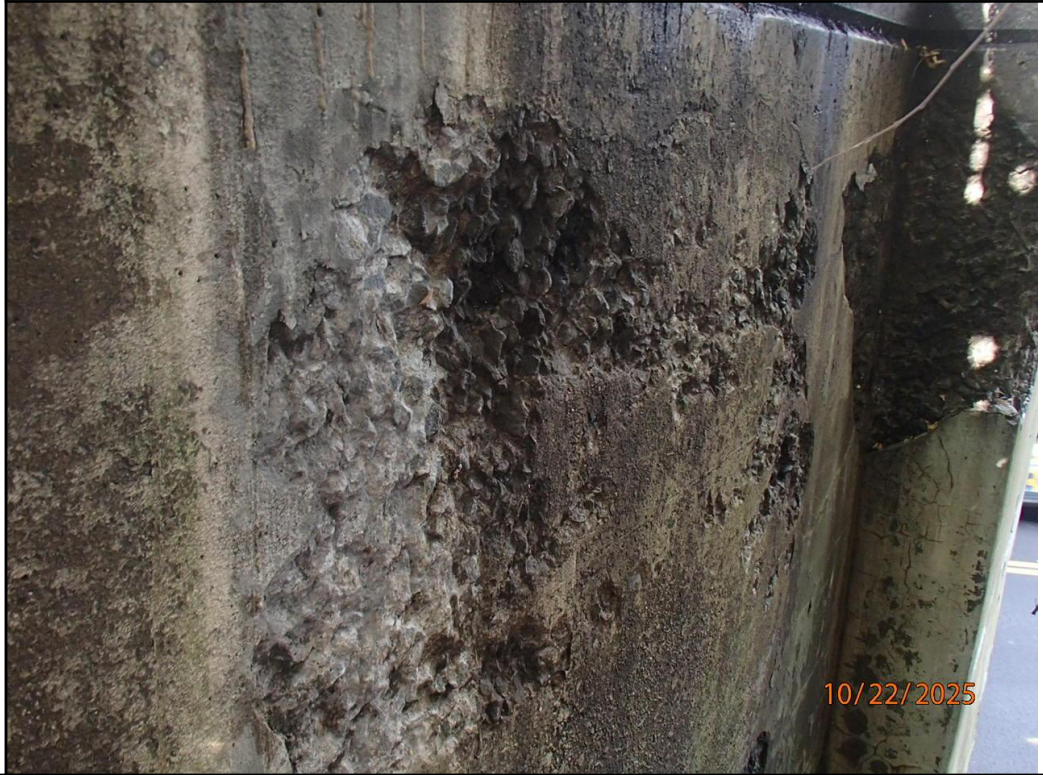
Photo Number: 31 Photo Filename: PA221052.JPG

Attachment Description:
End Left wingwall, looking
Begin Right.

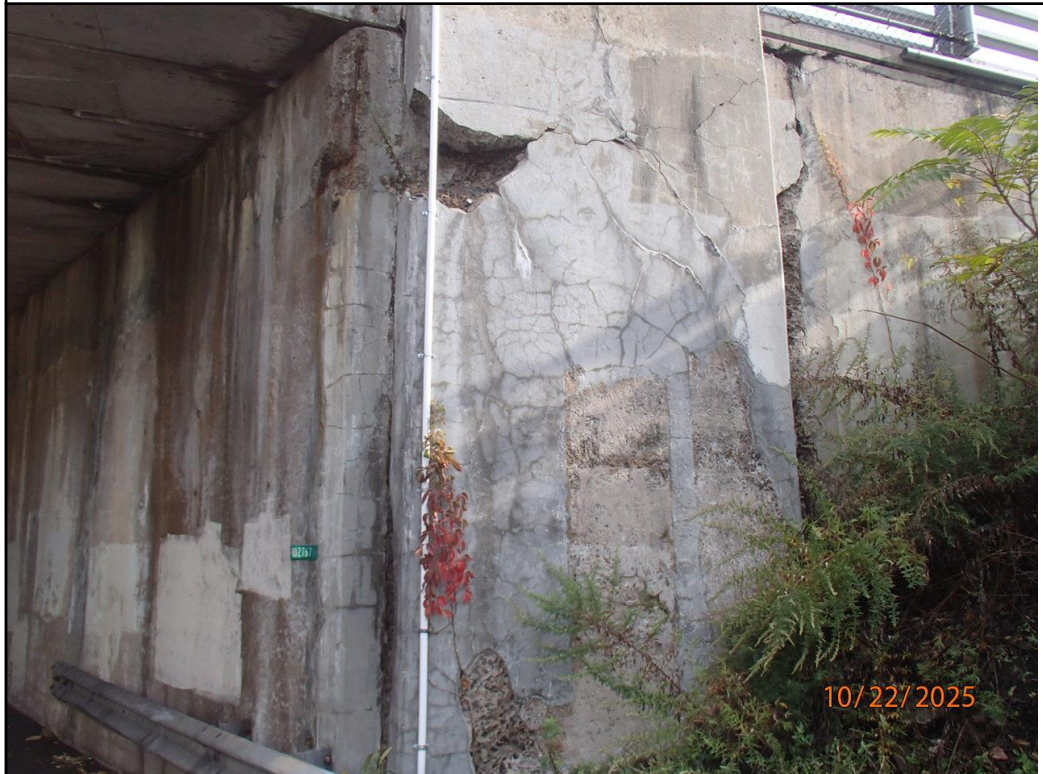
Photo Number: 32 Photo Filename: PA221068.JPG

- On the top Right face, there is an up to 3 ft. high x 2ft. long x 1 ft. deep x 1 ft. wide (FW) spall (Photo 24 and 32).
- On the front face of the cheek wall there is a 10" wide x 6 ft. high x 3" deep spall.
- On the Right side towards the Begin there is a 43" high x 27" long x 2.5" deep spall near the base.
- On the End Right back corner of the Right cheekwall there is a spall measuring 20" high x 6" long x 2" deep. The remainder of the cheek wall exhibits scatted patches with up to 1/4"W map cracking.
- The End Right wingwall at the cheekwall junction exhibits a full height x 2 ft. wide x 3" deep spalled/delaminated and crack area (Photo 33).

Attachment Description:
End Right cheekwall,
general view, looking End
Left.

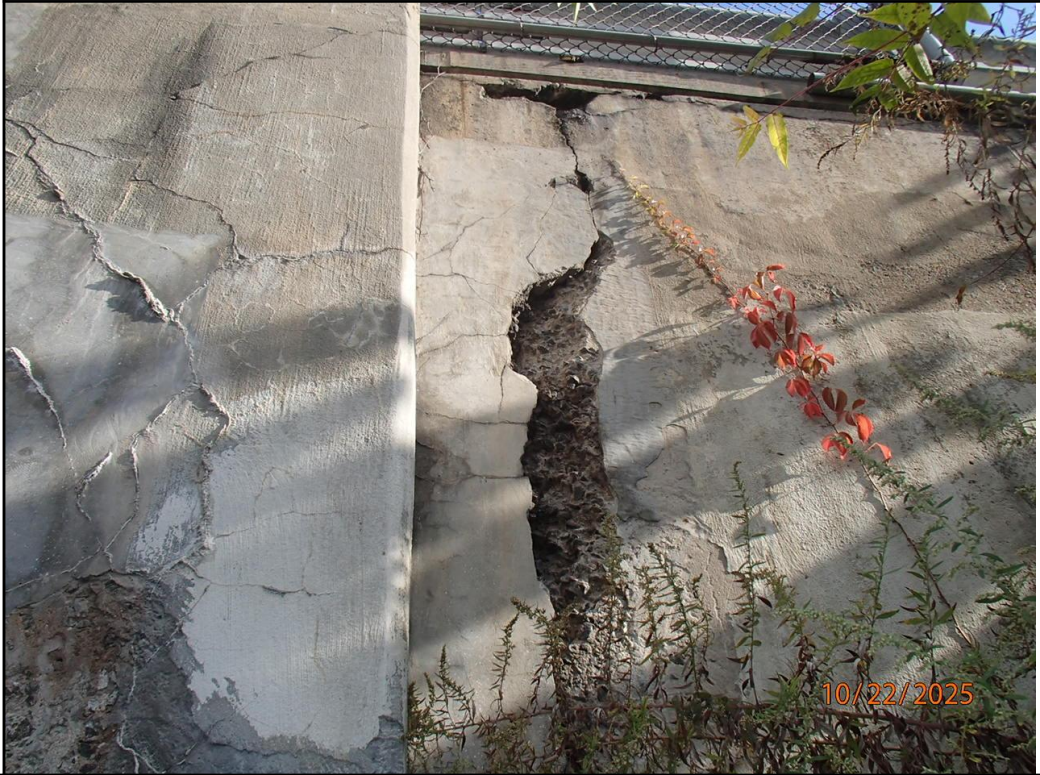
Photo Number: 33

Attachment Description:
End right cheekwall and
wingwall, looking Left.

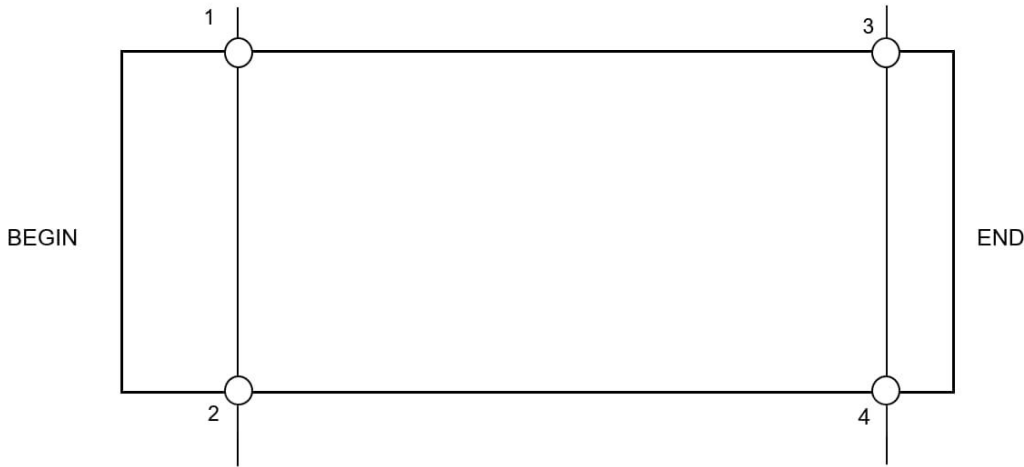
VERTICAL CLEARANCES UNDER BRIDGE

STATION	READINGS (FT-IN)					
	DATE	DATE	DATE	DATE	DATE	DATE
	2021	2022	2023	2024	2025	
1	17'-6"	17'-6"	17'-6"	17'-4"	17'-4"	
2	16'-10"	16'-10"	16'-10"	16'-10"	16'-10"	
3	16'-2"	16'-1"	16'-2"	16'-2"	*15'-11"	
4	15'-7"	15'-7"	15'-7"	15'-7"	*15'-5"

*The decrease in vertical clearance is the result of newly installed asphalt pavement beneath the bridge.

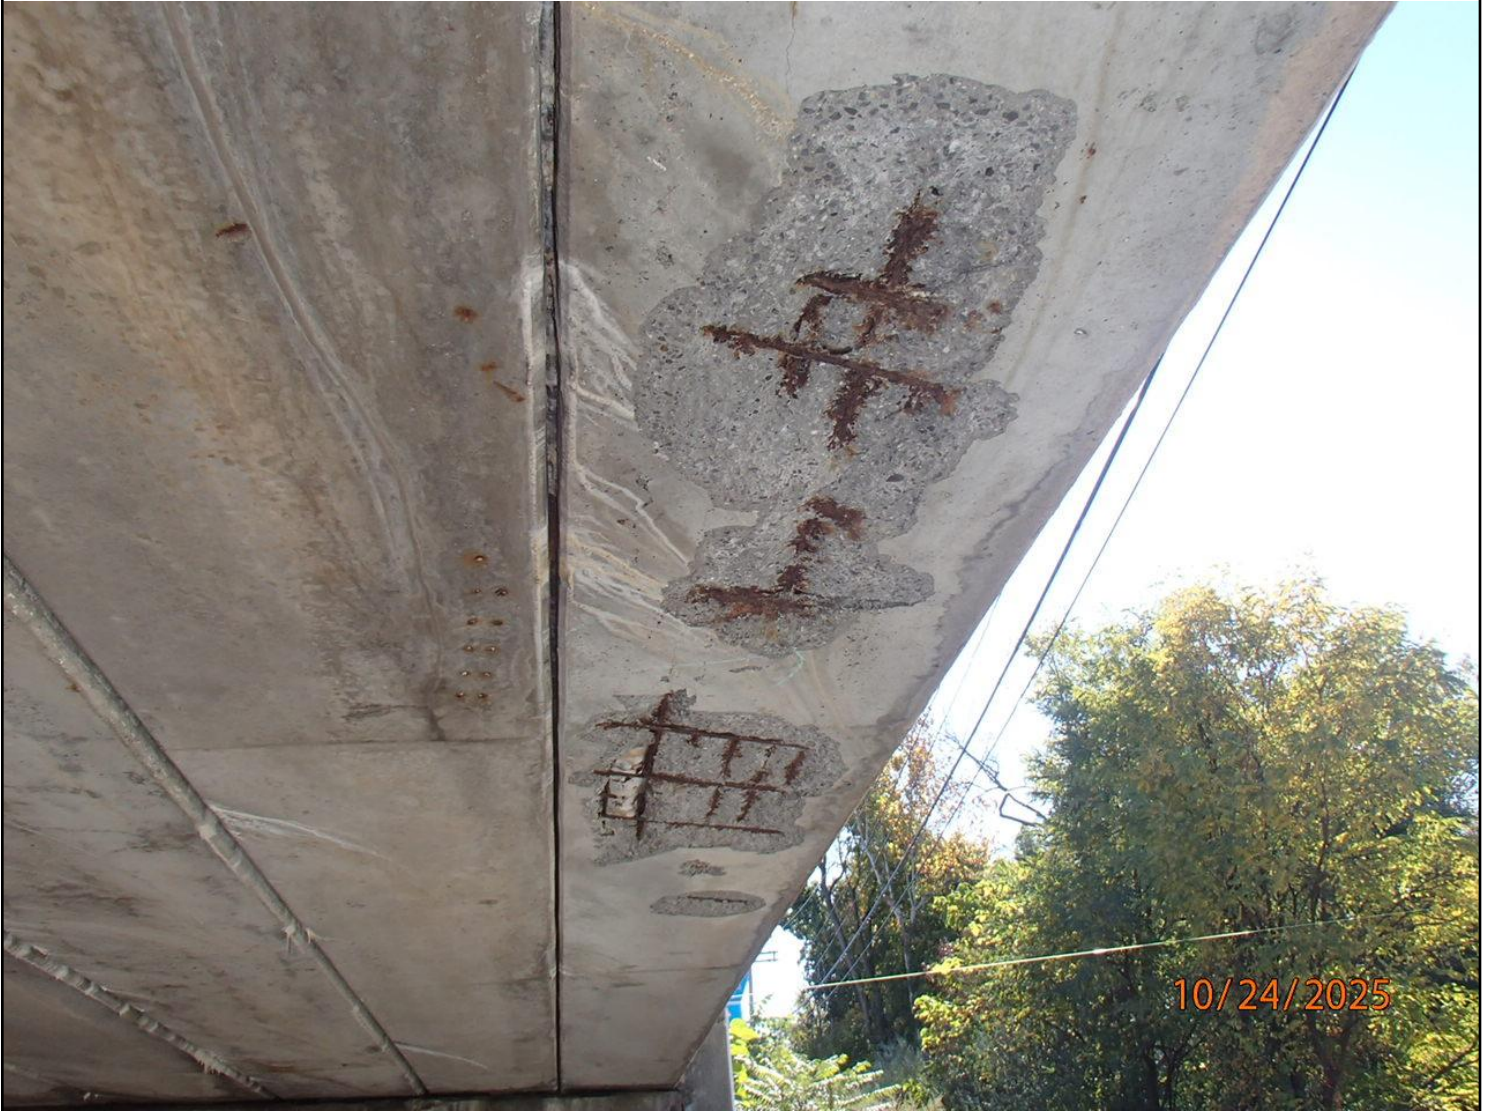
Photo Number: 3

-- Seven feet from the begin abutment there is a 6 ft. long x 2.5 ft. wide x 1.5" deep spall with 3 exposed longitudinal strands and 4 stirrups containing up to 25% section loss (previously 3 stirrups with 15% section loss) (Photo 3). Just beyond the spall, there is a 1 ft. long x 1.5 ft. wide hollow area between this spall and the next spall.

Attachment Description: Beam B17 Underside, General View, Looking End.

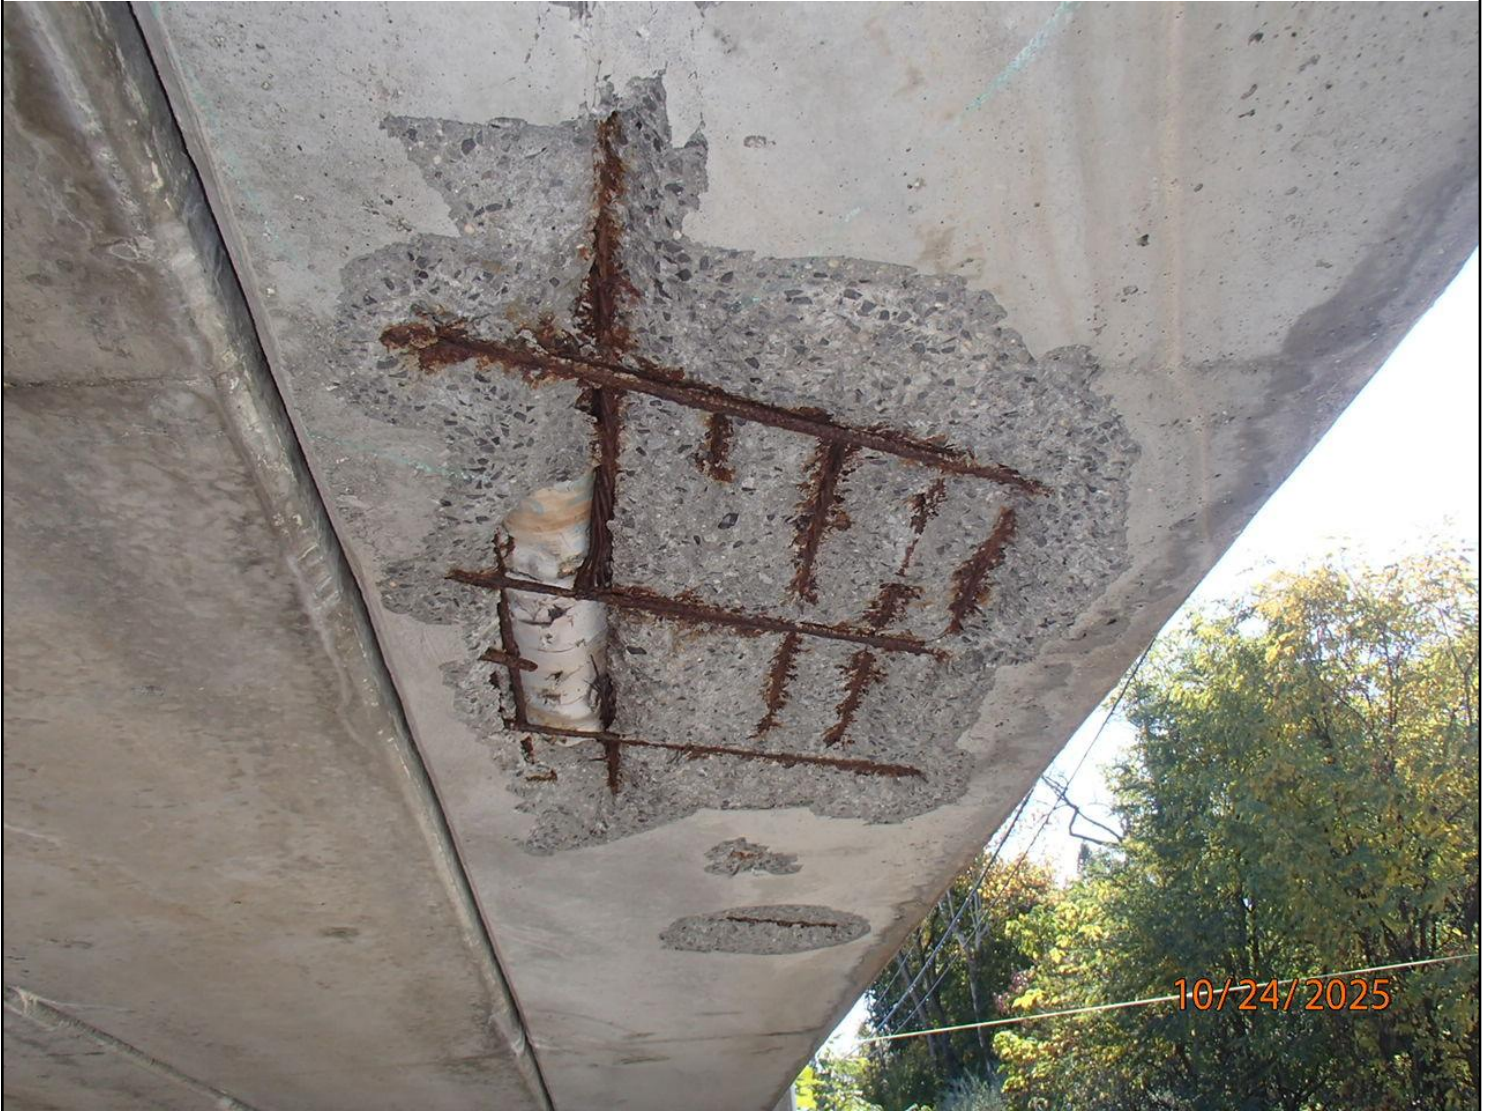
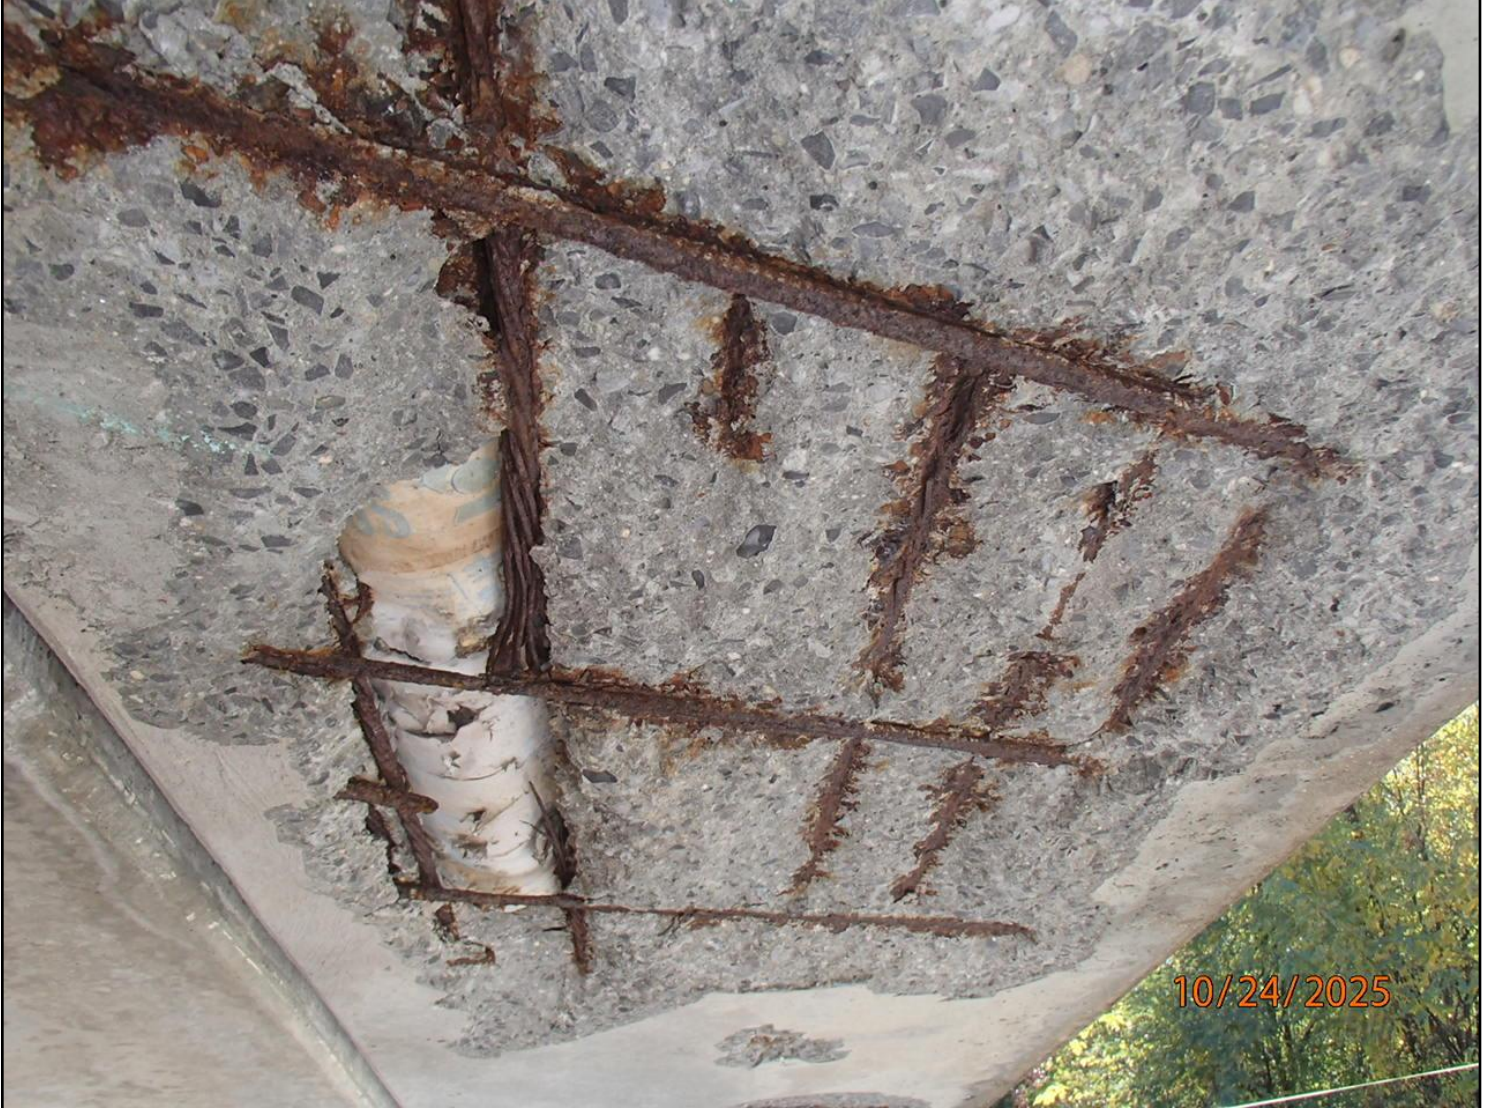
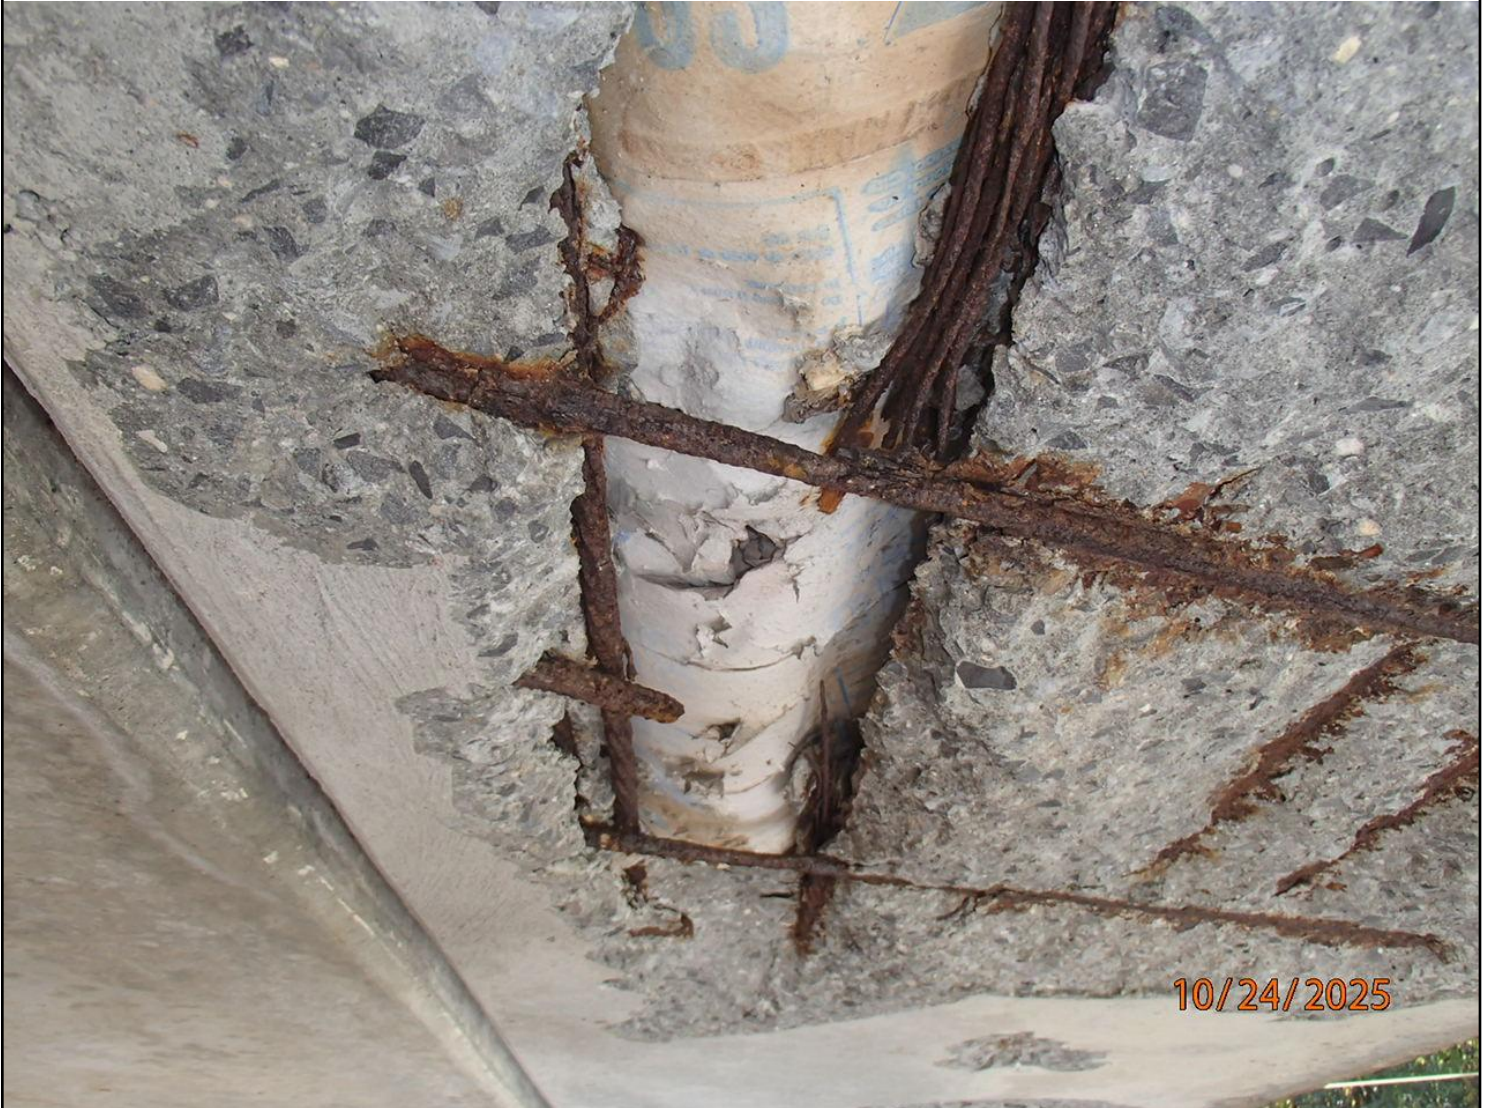
-- At 14 ft. from the begin there is a second spall which exposes one of the precast forms. The spall is 4.5 ft. long x 2.5 ft. wide x 3" deep spall with 7 out of 9 exposed bottom strands (no change) (Photos 4 to 6). There is one broken strand and the remaining are heavily corroded (no change). Based on the original plans it appears that the broken strand is the 4th from the left side. There are also 3 stirrups which exhibit up to 25% section loss. Just beyond this spall, there is an 8" diameter and a 16" dia. spall with 1 exposed stirrup each (no change).

Significance: The exposed and corroded strands are located at midspan which could potentially reduce the beam's capacity. Due to the heavy corrosion of the exposed strands in the bottom flange at midspan, a total of 7 strands in the bottom mat are assumed to be ineffective. In addition, strands directly above exposed and deteriorated lower strands are assumed to be ineffective for a total of 2 strands in the second mat. This bridge is posted for 18 tons due to previously noted spalling with exposed strands in Beam B17. Although this beam is located directly below the sidewalk, it does see some live load due to distribution through the deck. Updated load rating is pending. There are no flexure cracks or other signs of distress, therefore, Yellow Flag is reissued for continued monitoring.

Attachment Description: Beam B17 Underside, Spalls near Midspan, Looking End.

Attachment Description: Beam B17 Underside, Close-Up of Spall near Midspan, Looking End.

Attachment Description: Beam B17 Underside, Broken Prestressing Strand near Midspan, Looking End.
