New York State Department of Transportation General Bridge Inspection Report

Inspection Date: October 24, 2025

BIN: 1027670

General Type Main Span: 5 - Prestressed Concrete, 05 - Box Beam or Box Girders - Multiple

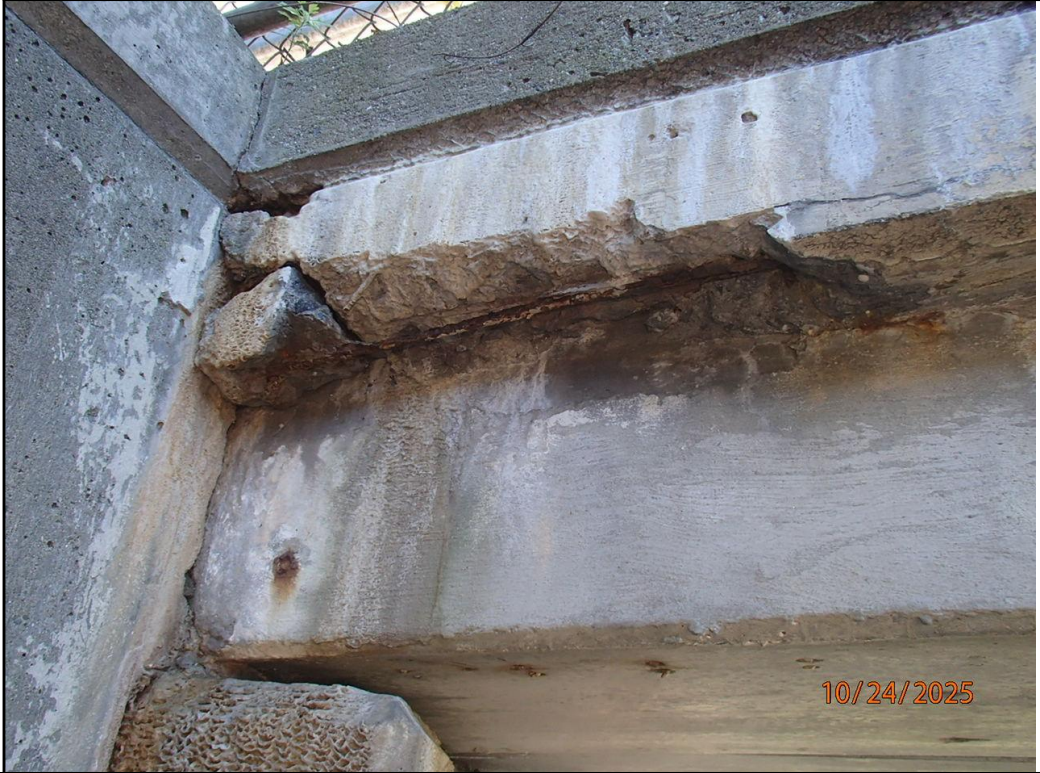
Span 1: 12 - Reinforced Concrete Deck	TQ	CS-1	CS-2	CS-3	CS-4
	2047	612	1428	7	0
Common					
<i>Referenced Photo(s):</i> 1, 2					
<i>Referenced Sketch(es):</i> None					
--The underside of the Left fascia at the End abutment exhibits a 26" long x 5" wide x 5" high x 2.5" deep corner spall with exposed rebar containing up to 75% section loss (Photo 1).					
--The right fascia exhibits small pop-outs/delaminations over the roadway throughout the span (Photo 2). No loose concrete was noted over the roadway below. See NSCO for more information.					
Span 1: 12 - Reinforced Concrete Deck-510 - Wearing Surfaces	TQ	CS-1	CS-2	CS-3	CS-4
	1713	1641	0	72	0
Common					
<i>Referenced Photo(s):</i> 3, 4, 5					
<i>Referenced Sketch(es):</i> None					
-- At the Begin in the Left lane there is a 52" long x 55" wide depressed area with a 13" wide x 10" long x up to 4" deep pothole (Photo 3). The surrounding area is cracked up to 1/4" wide.

Attachment Description:
Left deck fascia at End
Abutment, looking Right.

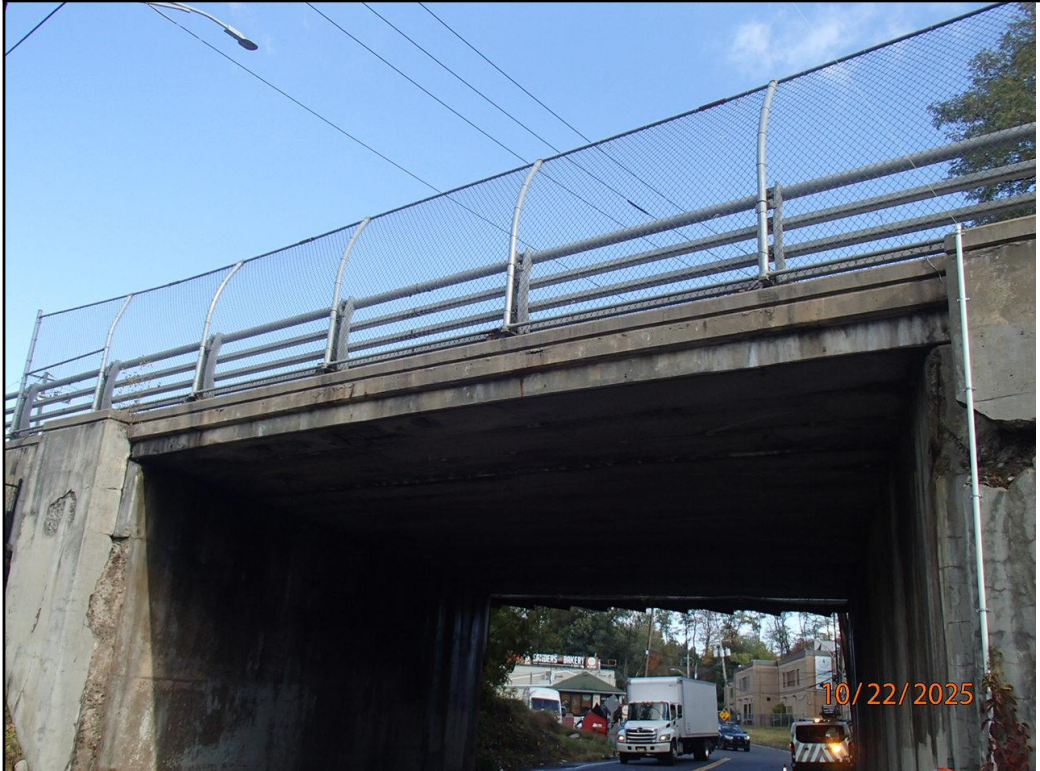
Photo Number: 2

-- The Right fascia of the deck exhibits small delaminations over the roadway for a 5 SF area total (Photo 2).

Attachment Description:
Right fascia, general view,
looking Begin Left.

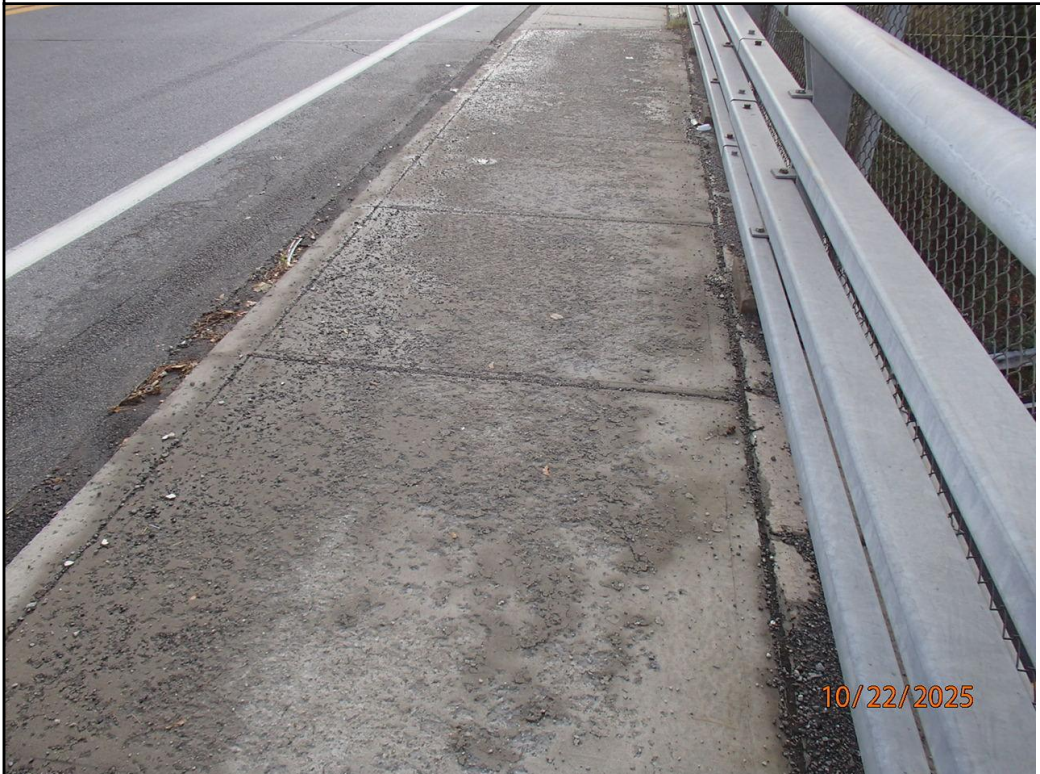
Photo Number: 26 Photo Filename: PA221049.JPG

Attachment Description:
Right bridge sidewalk, general view, looking End.

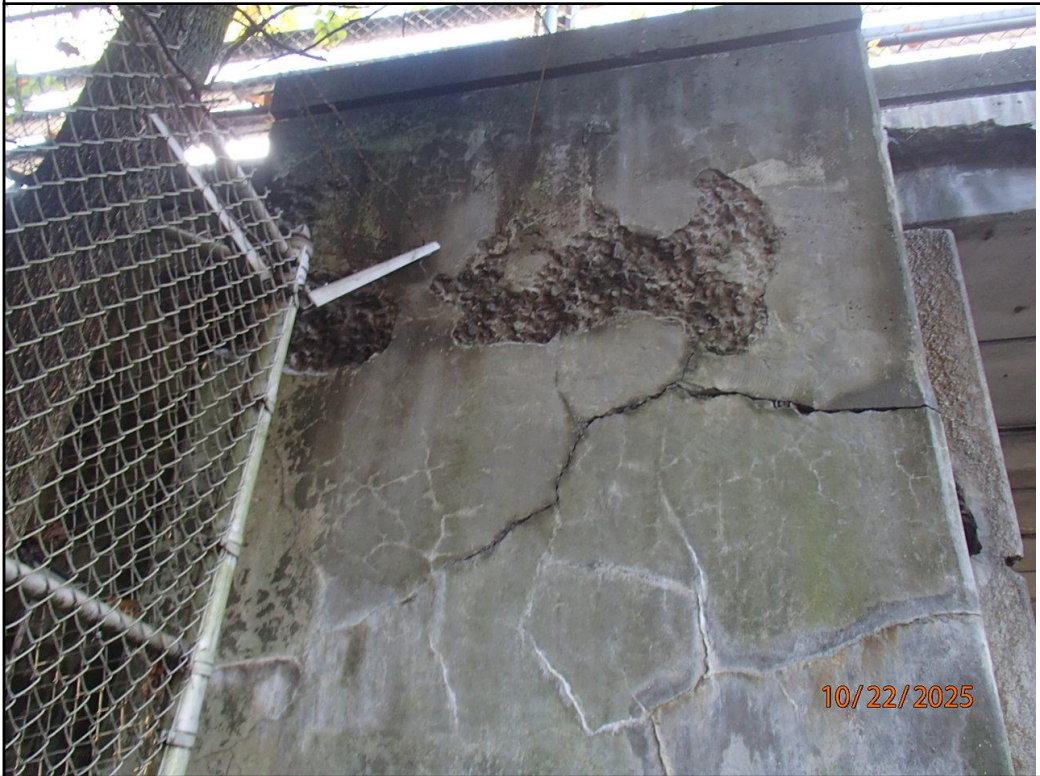
Photo Number: 30 Photo Filename: PA221054.JPG

Attachment Description:
End Left cheekwall at top,
looking Right.

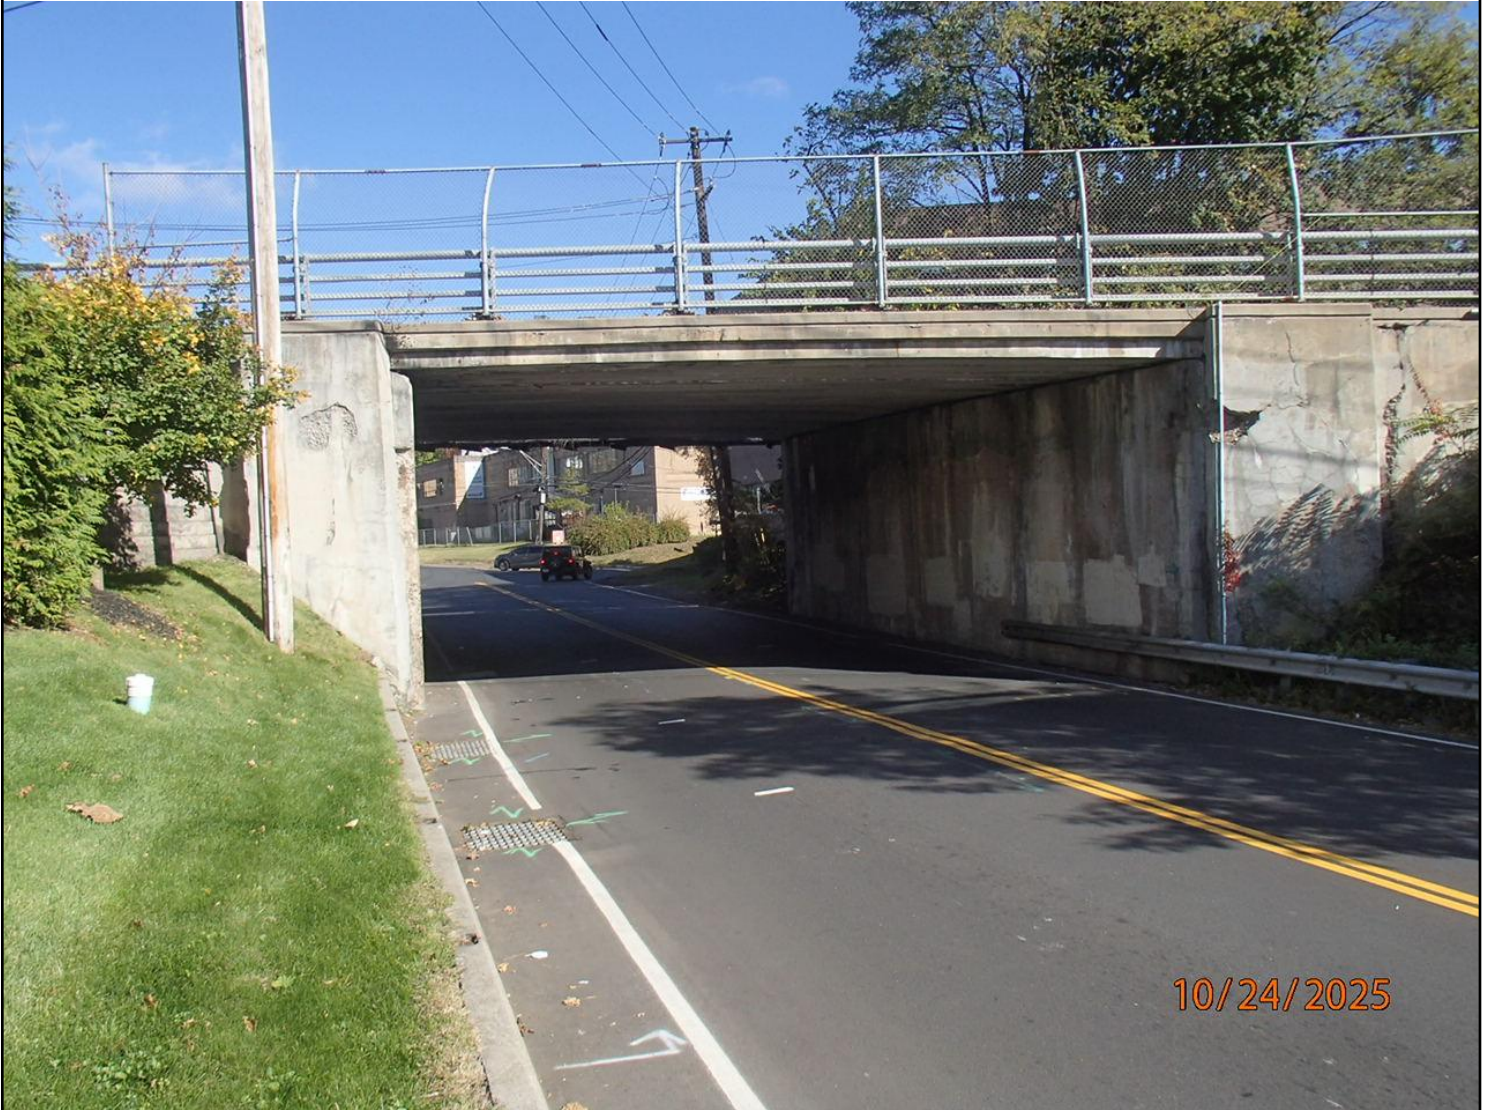
Photo Number: 1

The bridge is a 17-unit prestressed concrete voided slab bridge with a non-composite concrete deck (Photos 1 and 2). The beams are 2'-11.5" wide x 1'-3" high with 9 bottom and 4 second mat strands for a total of 13 strands. The underside of Beam B17, starting at 7 ft. from the begin and extending to midspan, exhibits several spalls with exposed and corroded rebar and prestressing strands over the roadway. The spalls are detailed from begin to end as follows:

Attachment Description: Right Elevation, Looking Left.

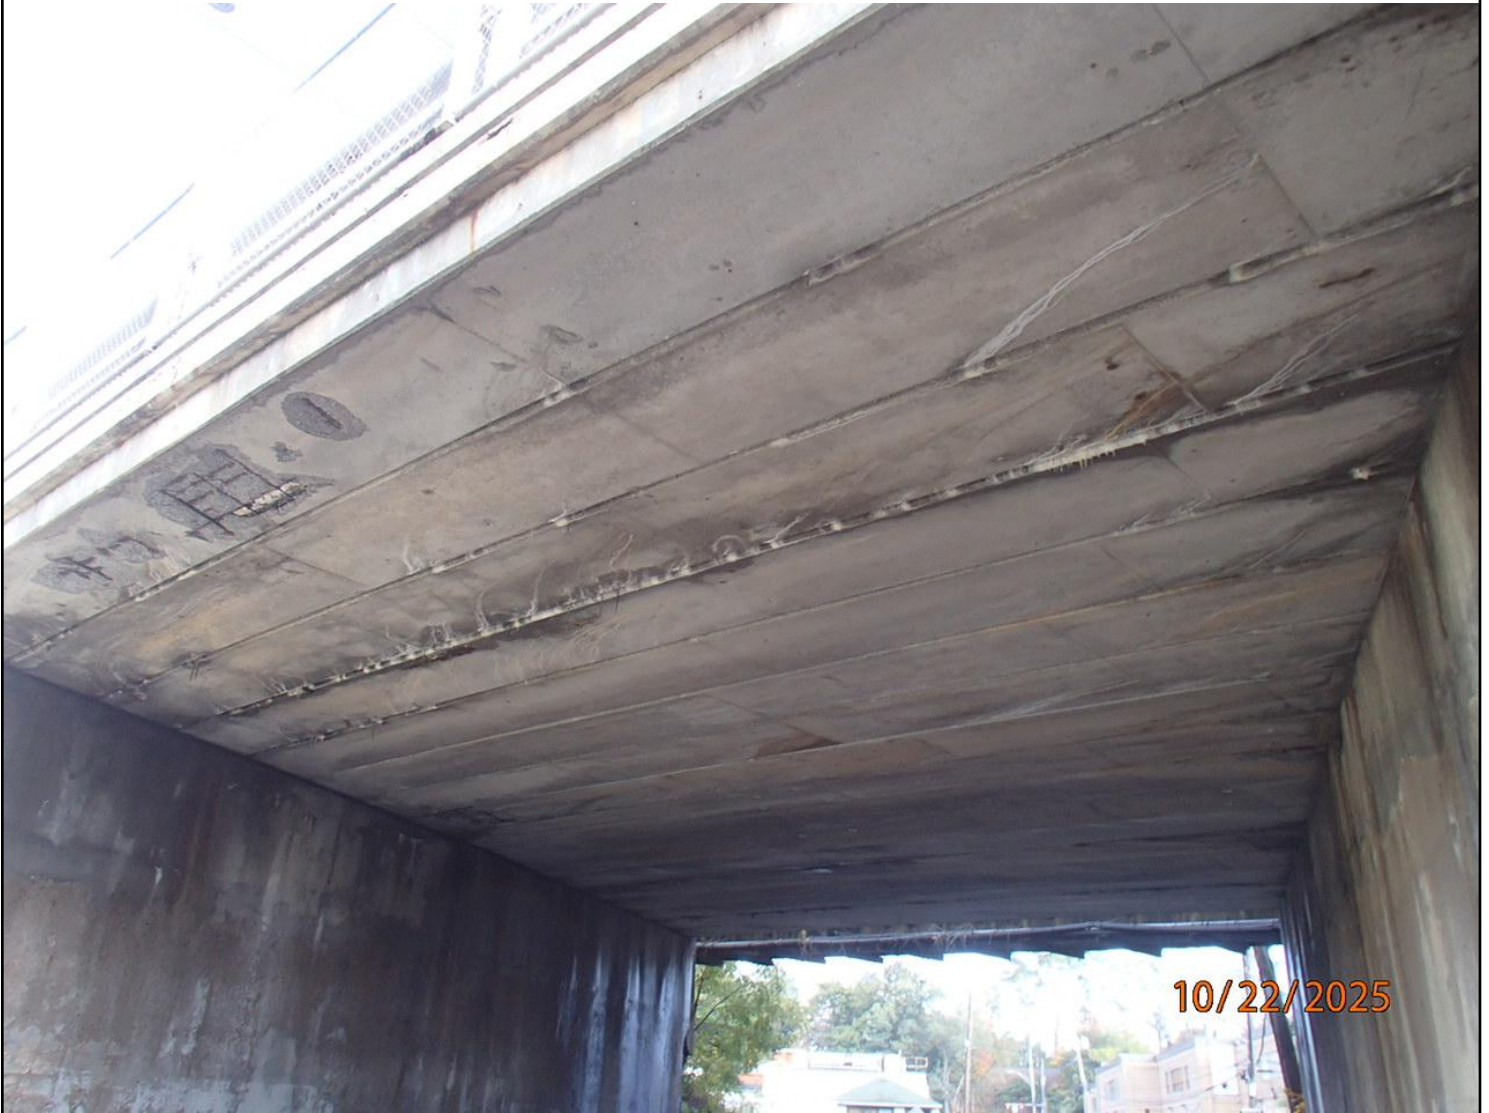
Photo Number: 2

Attachment Description: General Framing, Looking Begin Left.

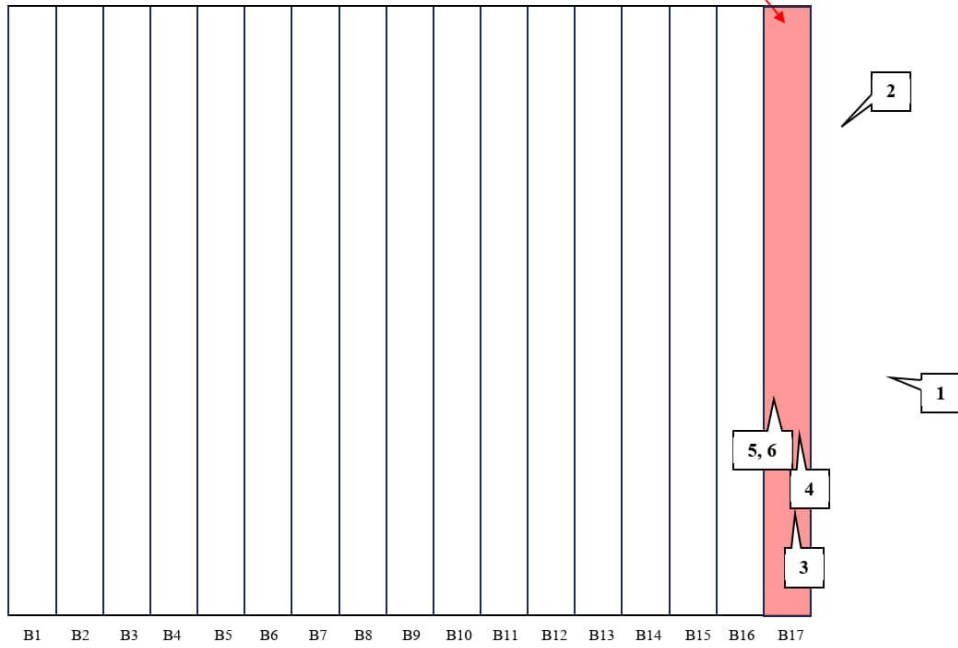
YF8B25ASW018 Location

Subject: Beam B17 exhibits spalling with exposed and deteriorated prestressed strands at midspan

Attachment Description: Flag Location Plan
